Warrnambool Breakwater – January 2018

Warrnambool City Council

Port of Warrnambool Asset Management Plan

Breakwater Assessment

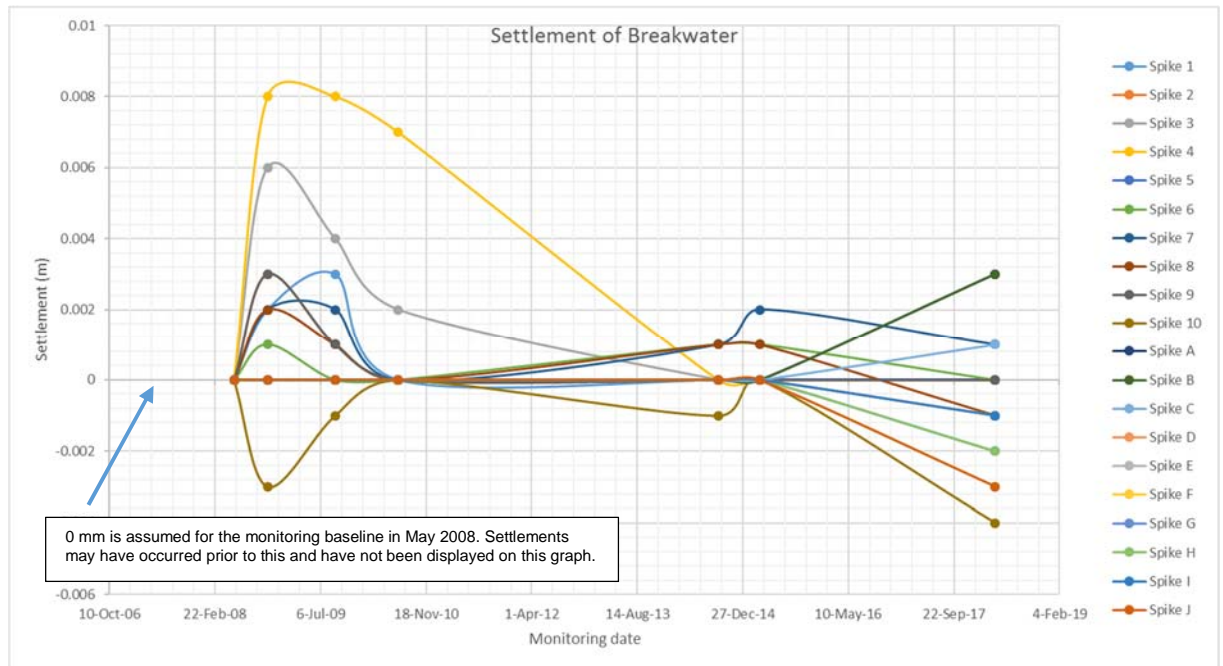
Figure 7 Warrnambool Breakwater monitoring of settlement

The survey monitoring data indicates that minimal movement in both the horizontal and vertical plane has occurred since the monitoring begin in 2008 (an approximate 10 year monitoring period). Maximum vertical settlements of approximately 4 mm was observed at Spike 10 and a heave of 8 mm observed at Spike 4. Maximum horizontal movements of approximately 12 mm were observed at Spike D with all remaining points indicating less than 10 mm movement.

Both horizontal (rotations) and vertical (settlements) of the breakwater appear to have reached a state of equilibrium and may be dormant. Based on our review of the survey data, significant further movement (both horizontally and vertically) is unlikely to occur in the near future without significant changes on the conditions experienced by the breakwater or foundations.

Spikes 1-5 and Spike 9 have been excluded from the survey data due to damage sustained to the points and these should be reinstated to allow for continuation of monitoring in these locations.

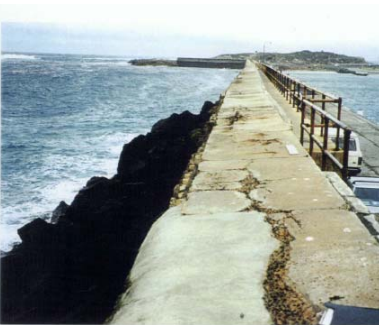
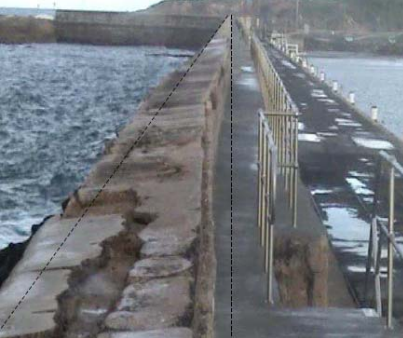
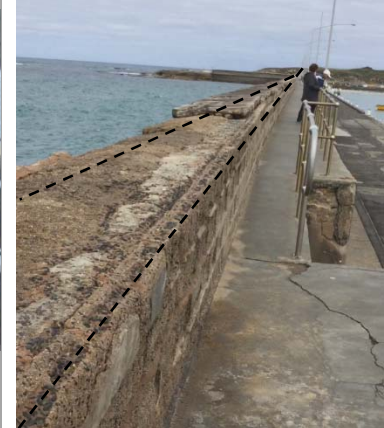
Photo 22: Rotation of elevated parapet blockwork at east end of breakwater	Photo 23: Rotation of elevated parapet blockwork at east end of breakwater	Photo 24: Rotation of elevated parapet blockwork at east end of breakwater)

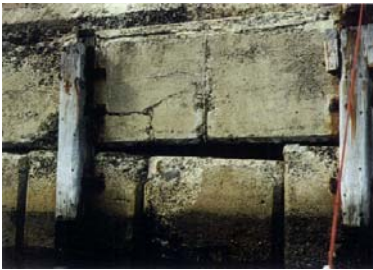
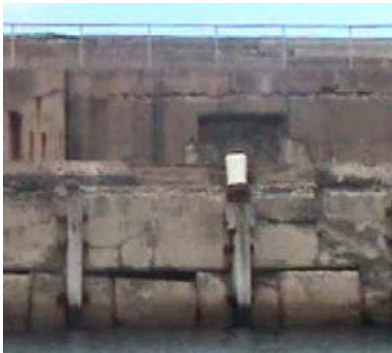
<p>Photo 43: Gaps observed at Bayside</p>

<p>Photo 44: Gaps observed at Bayside</p>

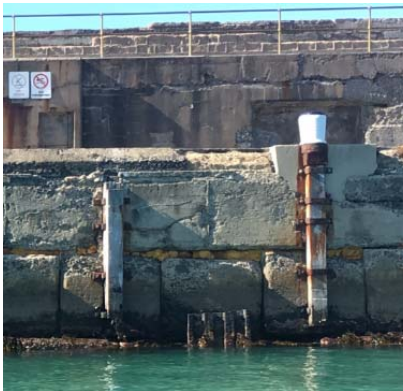
<p>Photo 45: Gaps filled at Bayside</p>

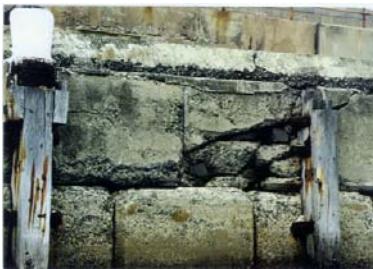
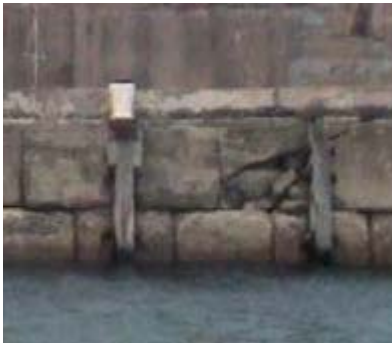
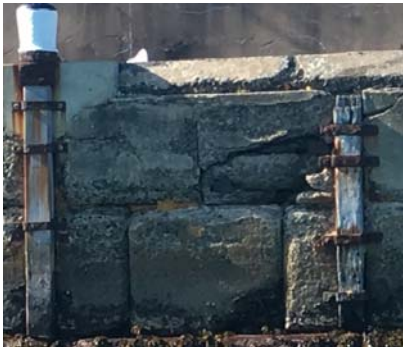
<p>Photo 46: Blockwork failure due to settlement observed at Bayside</p>

<p>Photo 47: Blockwork failure due to settlement observed at Bayside</p>

<p>Photo 48: Blockwork failure due to settlement observed at Bayside</p>

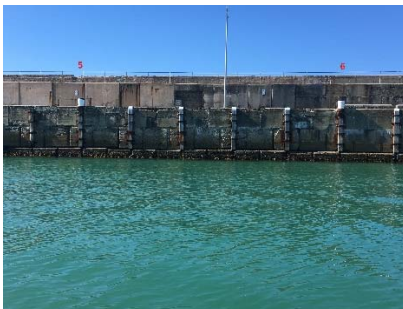
Connell Wagner report, 1998	Connell Wagner/Aurecon report, 2006/2009	GHD/Council Photos, 2017/18
		Photo 49 – Leeching of masonry block joints commencing at Bollard 5-6
