Warrnambool City Council

Merri River Restoration Strategy

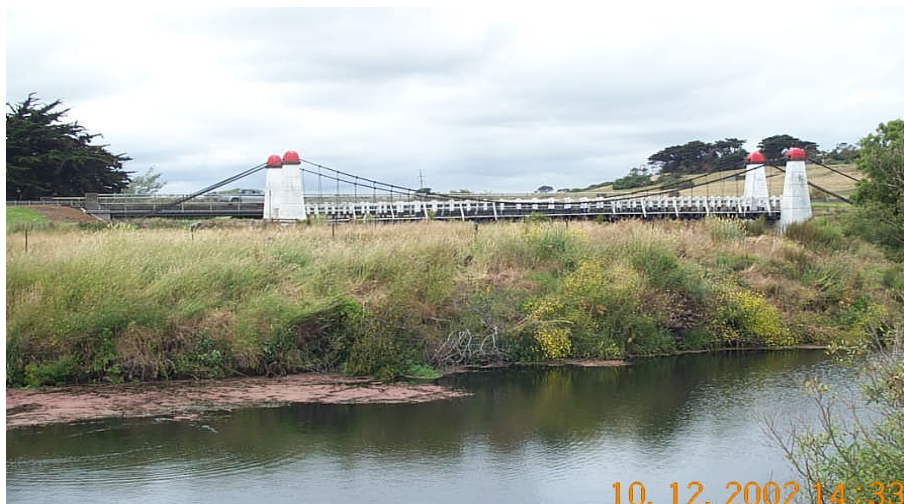
Photo 2: WOLLASTON BRIDGE

The Land Conservation Council listed Wollaston Bridge (Photo 2), constructed in 1890, as a site of cultural heritage in 1989. Further upstream, near Woodford, is located the remains of Struth's Mill, built in 1847 and the first water powered mill built in Victoria.

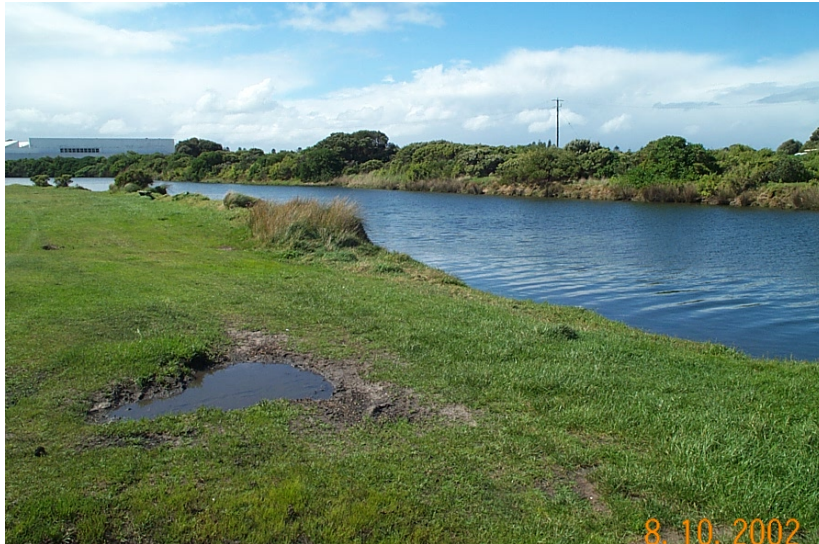
Photo 3: Ferrier Drive Reserve.

This area of the river extends between the Stanley and Harris St Bridges. Its boundaries consist of the Ferrier Drive Reserve on the west and Lake Pertobe to the east. The eastern bank is heavily vegetated, predominantly with natives, whereas the western bank consists of an open grassed flood plain (Photo 3).

- Remove exotic weed species.
- Revegetation work along riverbanks.
- Interpretive signage at viewing platform.
- Investigate possible placement of picnic table within reserve area.

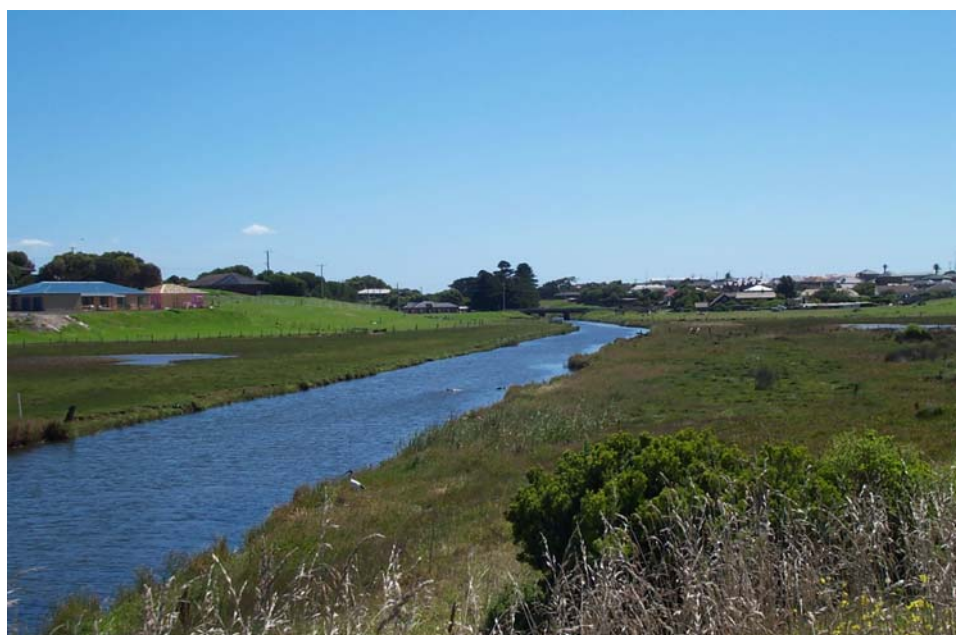
Photo 4. Harris Street to Wellington Street.

This run of the river is found between Harris and Wellington St Bridges and consists of flood plains both sides of the rivers (Photo 4). There is a 10m wide strip of land either side of the river that is owned by NRE and is presently leased for stock. A management plan is being prepared by WCC with the aim of fencing and regulating stock access.

This area has been identified as a salt marsh habitat, which is Orange-bellied Parrot winter habitat and therefore should be managed to retain the vegetation while improving the water quality of water run-off into the river. As past grazing by kangaroo and wallabies etc would have contained the biomass there is a view that selective grazing, by stock, during selective times of the year may be used. The management of this area is presently being looked at by WCC in partnership with DSE.

- Remove boxthorn and exotic weed species.
- Fence both riverbanks to prevent stock access.
- Revegetation work along riverbanks.
- Interpretive signage at existing viewing platform.
- Placement of picnic table in reserve area beside Harris St.

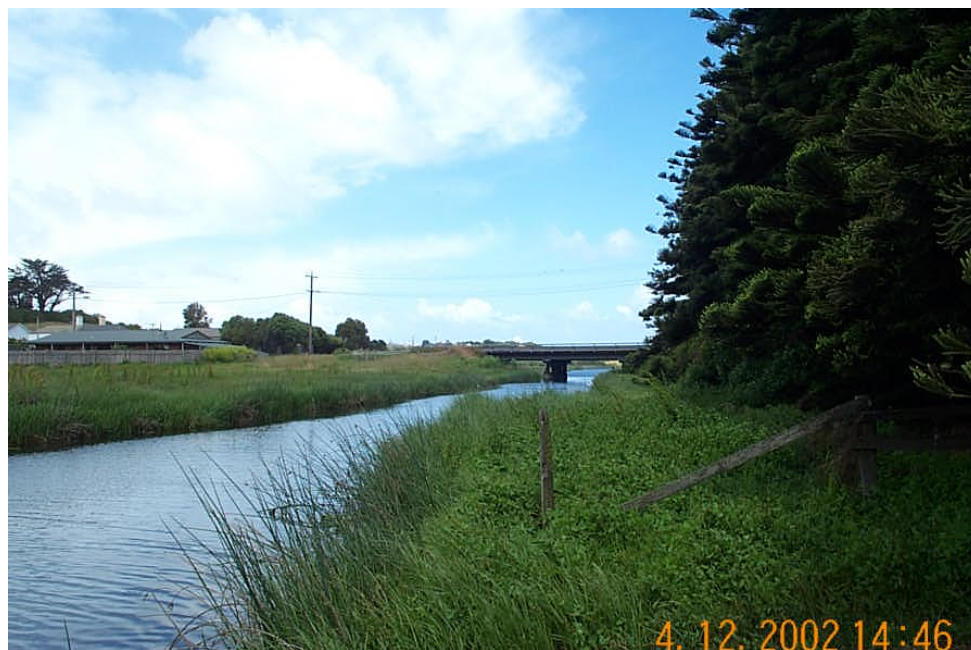
Photo 5: Fairway Block

The eastern end of the block features 36-40 mature Norfolk Pines in two rows running parallel to the riverbank (Photo 5). A local Landcare Group has carried out some revegetation work in the western corner of the block. Bank topography in the middle section is high with little vegetation behind the fenced plantings, however Boxthorn is regenerating within the revegetation area. The western end of this block consists of a low-lying floodplain with the dominant vegetation consisting of introduced pasture grasses. Properties adjacent to the river have no pastoral purpose and as such, aesthetic values of the area can be enhanced through revegetating without erecting fences between crown & private land. Total bank length of this block is 564m. Access is gained via two WCC owned blocks in Fairway Crescent and from The Wellington St Bridge.

- Remove boxthorn and exotic weed species from amongst Landcare revegetated area & riverbank.
- Plant additional plants within Landcare revegetated area and along riverbank on floodplain.
- Preserve the Norfolk Pines in the Eastern area and the planting of understory plants.
- Investigate possible placement of picnic table between Norfolk Pine rows
- Open space on blocks adjoining Fairway Cr blocks maintained for recreational use.
- Revegetated crown land should remain unfenced from adjacent private properties

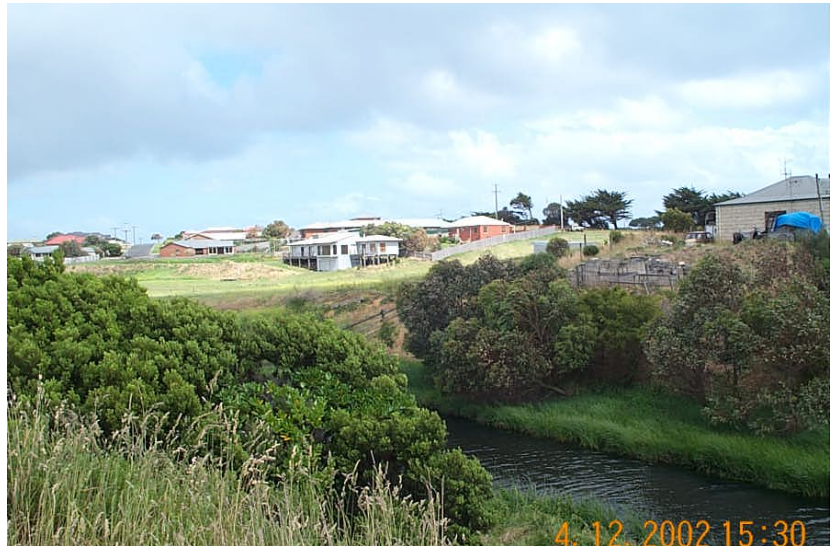
Photo 6: Duirs Block

Duirs block lies along the north bank of the Merri River between Wellington Street Bridge and Block Street. Its vegetation is composed exclusively of pasture grasses, except for several native shrubs growing up the bank near a viewing platform/jetty at the Duirs Street extension.

Topographically, this block has a low profile at its eastern end, rising to the middle at the river bend, before lowering again to the west. Parts of the crown land extending along the bank have been incorporated into the properties running parallel to the river. The viewing platform/jetty provides the only established pedestrian access point to the river within the project area. The crown land along this block is 25m in width, with a total bank length of 794m. Access is possible via the Duirs Street extension and Block Street.

- Removal of weeds both mechanically and chemically.
- Path construction and maintenance from Duirs St to platform/jetty between revegetation areas.
- Revegetate crown land through planting & incorporate with WCC 'Northcote Dr' reserve.
- Revegetation to take into account future shared footway along river.
- Access from Duirs St to river viewing platform/jetty preserved.
- Access to riverbank for launching recreational craft (kayaks/canoes) should be available.

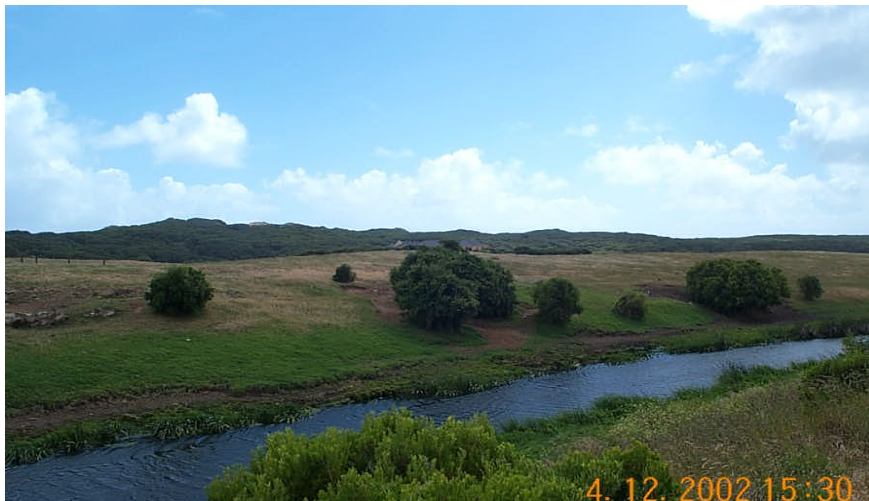
Photo 7: EROSION & BOXTHORN ALONG WCC PROPERTY.

This block has been greatly ecologically degraded. The absence of fencing allows stock access to the riverbank, combined with the proliferation of boxthorn **Photo** and the resulting rabbit infestation has caused extensive erosion lowering water quality downstream.

Rabbit warrens are extensive along this section, especially upon hillocks where vegetation is especially sparse. At its western end, this block divides some residentially developed areas from the knackery, and accordingly can be planted out to form a barrier between these areas. Total bank length is 1,893m. Neighbouring properties are owned by WCC. Access to this block could not be determined.

Key Actions
<ul style="list-style-type: none">• WCC should include environmental protection into their lease agreements.• Fence crown land reserve from riverbank and revegetate.• Combat rabbits through baiting/burrow ripping & the erection of rabbit-proof fencing.• Investigate alternative stock watering methods, pumps etc.

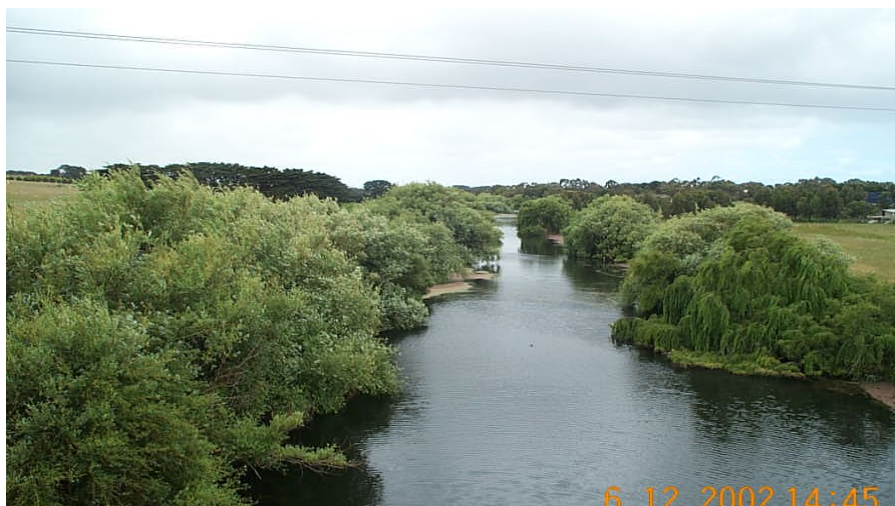
Photo 8: EXOTIC TREE INFESTATION UPSTREAM OF CASSADY'S BRIDGE

This block is comprised of Public Open Space lying along the south bank of the Merri River from Cassady's Bridge upstream to Morriss Road. The block is 10m wide along 415m of riverbank. Vegetation along this block is predominantly mature Willows and Poplars.

Density of these species in places overshadows understory grasses and weeds, resulting in degraded riverbanks with much erosion and root systems that strangle the river. Due to the narrowness of the block, coupled with the hindrance posed by exotic tree infestation, access for works along the block is difficult with access needed to be negotiated with neighbouring landholders. The largest adjacent landholder is Ryan's Properties Pty Ltd.

- Negotiate with adjoining landholders to gain access to block via their properties.
- Remove mature willow trees from along riverbank with chemical use eg: injection.
- Hemlock to be managed.
- Plant out bank with GHCMA suggested species.

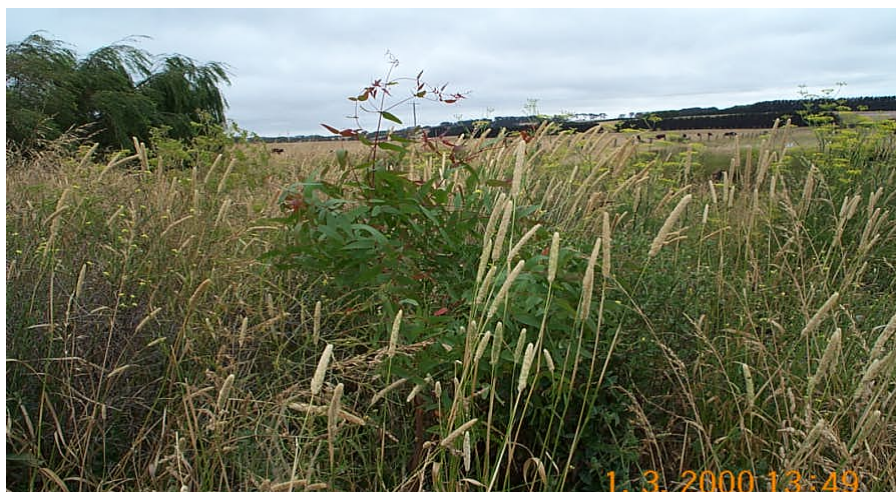
Photo 9: PLANTED EUCALYPT OVERSHADOWED BY TALL GRASS

The western end of the block is maintained by Parks & Gardens for a playground and public open space. The majority of the eastern end is covered in grasses and exotic weeds up to 1.5m high. Riverbank vegetation is scarce save for weeds and a grove of mature poplar trees near the Membery Way access point and two mature willow trees at the eastern end.

Fence lines with neighbouring properties are lined with native Eucalypts. Some revegetation works have been undertaken already, to mixed success. River red gums, *Eucalyptus camaldulensis*, have been planted in a line through the western end of the block, numbering around ten. Plantings of other Eucalypt species have been undertaken towards the western end of the block, though these have been to limited success due to poor maintenance that has seen grass and weeds overshadow the seedlings. Only fourteen of these were observed, within a height range of 0.7–1.5m. Access to this block is best achieved via Membery Way.

- Mow long grasses & weeds for several months to limit proliferation of hemlock and stimulate growth of Eucalypts planted at eastern end.
- Remove willow and poplar trees from banks along site.
- Demolish corrugated-iron shed mid-way along bank, as it is an eyesore serving no purpose.
- River access point, currently across park from Membery Way access point, should be upgraded.
- Views of the river from Kingston Close residences should be preserved if non-compromising to environmental goals.
- Plant CMA suggested species along length of bank and in patches throughout block (see Map 2.2).
- Designate some sections of bank to be planted with low-height species to preserve river views.
- Allow room between plantings for future track to run alongside river on this block.

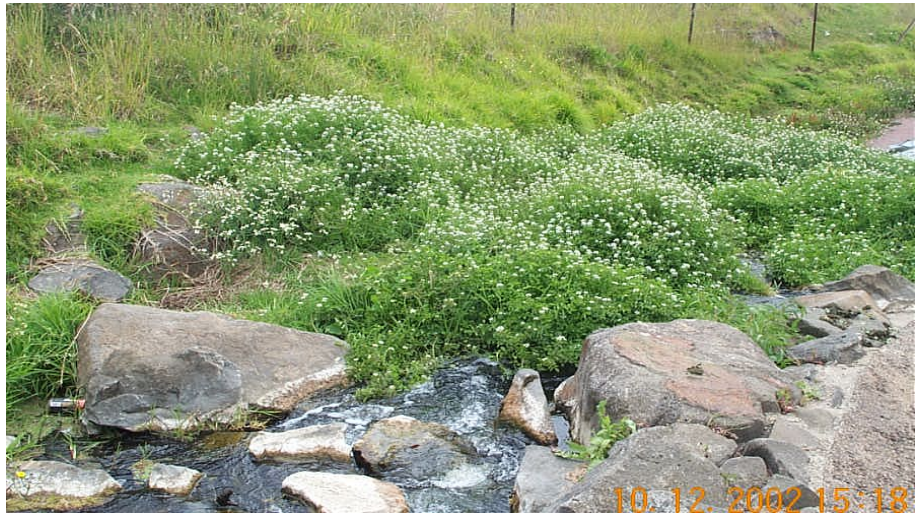
PHOTO 10: FISH LADDER & WEEDS AT THE WEIR.

This block encompasses the road extension of Bromfield Street north of Dalton's Road and the private property at 138 Bromfield Street. Total bank length on block is 376m. Riverbank vegetation mostly comprises weed species along the bank, with several mid-size exotic tree species at intervals.

A juvenile willow (<3m high) grows adjacent to the weir. Space for car parking and a river access point need to be preserved. Species adapted to high-traffic area are recommended and appropriating the WCC land incorporated into 138 Bromfield St will allow more effective revegetation to be planted. Access to this block is available via the Bromfield St–Dalton's Rd corner.

- Discuss revegetation with the landholder using CMA as an intermediary.
- Remove weeds and exotic trees from the riverbank.
- Place barrier back from weir to prevent parking close to bank and subsequent erosion.
- Consult private landholder and enquire if paddock is intended for grazing. If so, fence from paddock to protect seedlings.
- Investigate planting native grass species along sides of the fish ladder that withstand human traffic.
- Plant limited height species near weir that over time will preserve access to the weir without damaging its structural foundations.
- Plant out CMA suggested species along riverbank and in a shelterbelt running along the Eastern length of the Bromfield St extension.

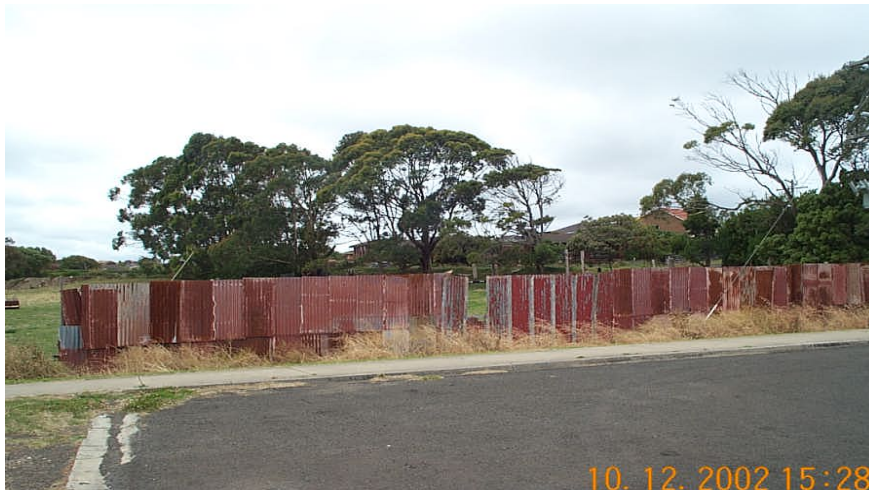
Photo 11: ECOLOGICALLY IMPORTANT TREES & DELAPIDATED FENCE ON WCC PROPERTY.

St James Park is a vast reserve containing a wetland area, numerous exotic trees and the historically significant Wollaston Bridge.

- Car parking area should be delineated to reduce spreading erosion caused by vehicles.
- Large willows/poplars should be removed from riverbank downstream of bridge.

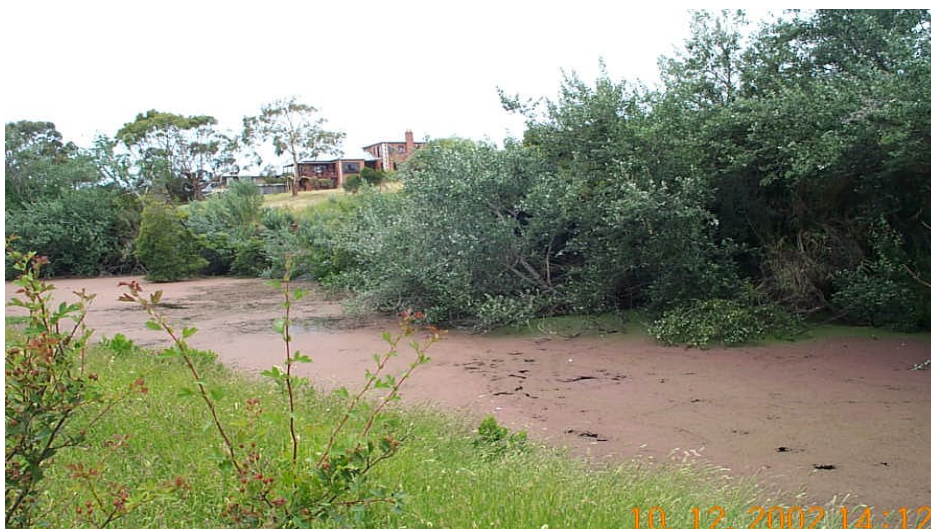
PHOTO 12: AZOLA COVER ON MERRI RIVER.

Total bank length within the block is 1,109m. The riverbanks along this block are especially infested with exotic species, with willows and poplars featuring prominently. In areas with less exotic trees, grass overshadows most weed species, growing to a height of over one meter.

- Obtain landholder cooperation in riverbank restoration plan. This will primarily involve gaining access to public open space through private land.
- Fence property boundaries to keep stock from gaining access to plantings and riverbank.
- Remove willows and poplars replacing them with native vegetation over time to retain bank stability.
- Investigate the placement of native wood snags in river to encourage better river flow and fauna habitat.
- Replace cypress stand adjacent to Wollaston Rd with natives as cypress trees die.
- If non-floodplain areas of private property adjoining reserves are to be subdivided in future, recommend that public open space be obtained at river bend, so wider sections of riparian zone can be restored.

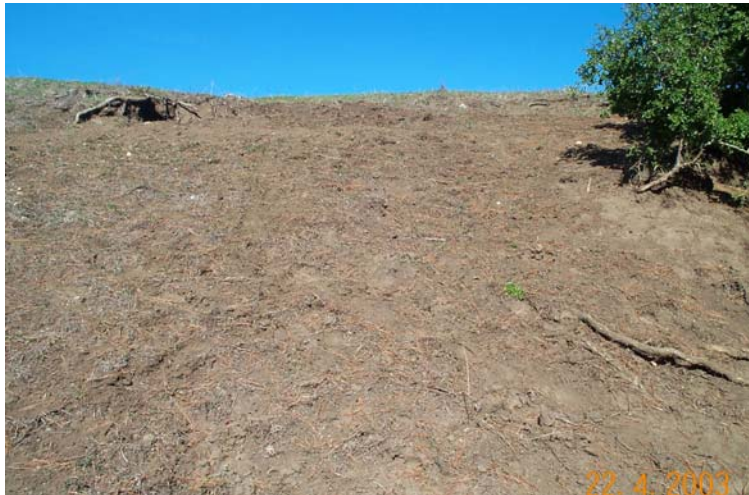
PHOTO 13: SHOWS THE EFFECT OF RABBITS AND STOCK ON A SECTION OF UNFENCED RIVERBANK.

These two blocks are found on the north and south sides of Grange Road. Block 1 is approximately 230m south of Grange Road and is 30m wide and 62m in length and is the smaller of the two blocks. The riparian vegetation consists of pasture grass and boxthorn. The area is not fenced allowing stock access to the river. Between stock and rabbits sections of the riverbank have been denuded of any form of vegetation and is open to erosion (Photo 13).

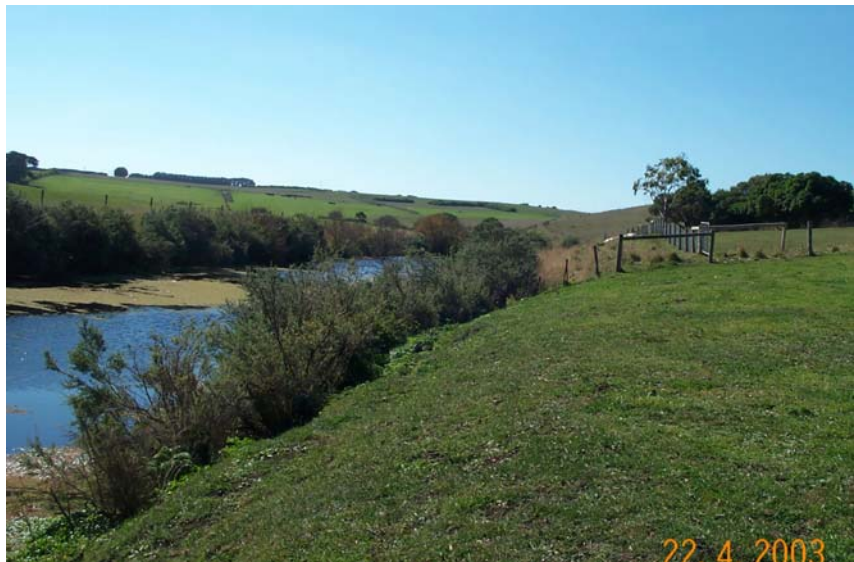
PHOTO 14: NORTHERN GRANGE BLOCK.

Grange block 2 is a larger block at approximately 217m long with a width of 20m. A small section of this area has a shallow vegetation strip of tea tree. There is some stock access in the form of lamas. The Grange Road Reserve is has a continuous southern boundary of boxthorn and is also heavily infested with briar rose.
