# Traffic Impact Assessment

147 WOLLASTON ROAD,  
WARNAMBOOL

Development Plan Appendices - 147 Wollaston Road Warrnambool  
Approved 5 December 2022

Client: Gull Group  
 Issued: 4/11/2022  
 Version: 2.0  
 Prepared by: Max Small  
 Checked by: Jimmy Liakos  
 Project Manager: Antonia Erceg  
 Project Number: 2000243

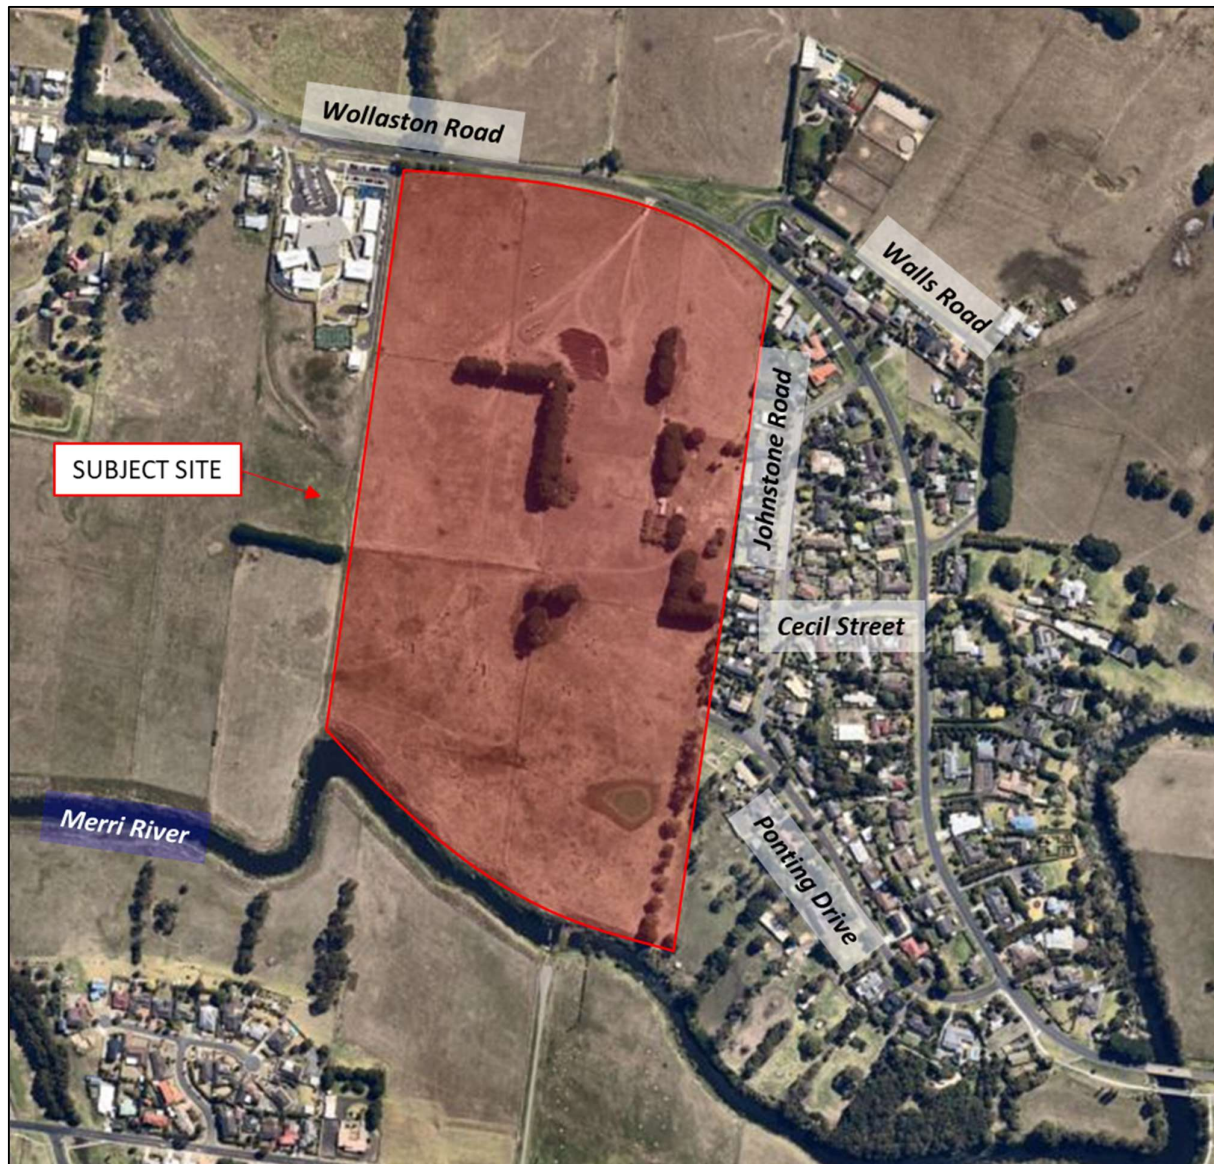
Figure 1: Subject Site – Existing Conditions

The existing site conditions are shown in Figure 1.

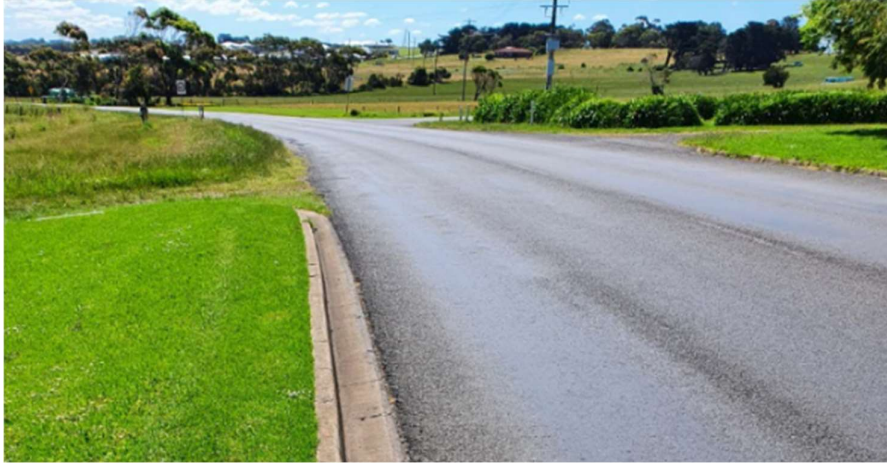
Figure 3: Wollaston Road facing west

At the frontage of the site, Wollaston Road is a two-lane, two-way road with 7m-wide carriageway and a posted speed limit of 80km/h. The roadside has grassed verges with no road shoulder. East of Walls Road the posted speed limit is 60km/h and the road is kerbed with no footpath on both sides of the road.

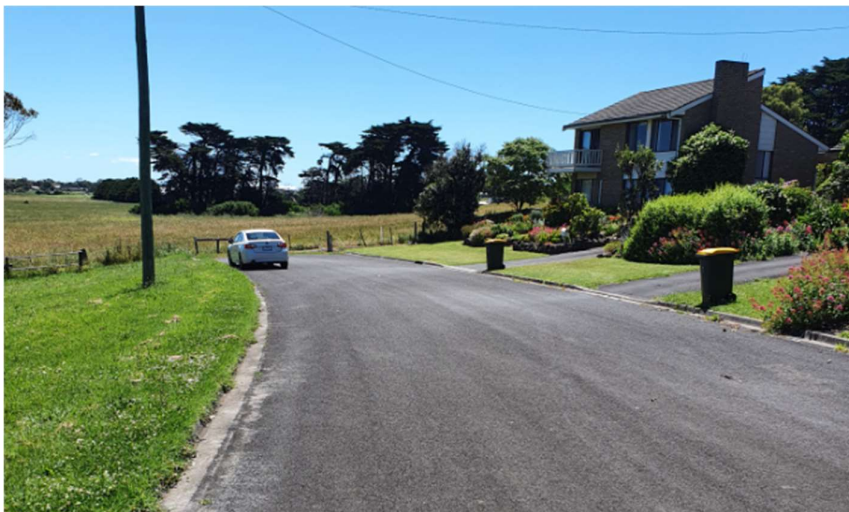
Figure 4: Ponting Drive at the site boundary

At the eastern boundary of the site Ponting Drive is a two-lane, two-way road with pavement of approximately 8m between kerbs. There are no footpaths and wide nature strips on both sides of the street. The speed limit is a default 50km/h.

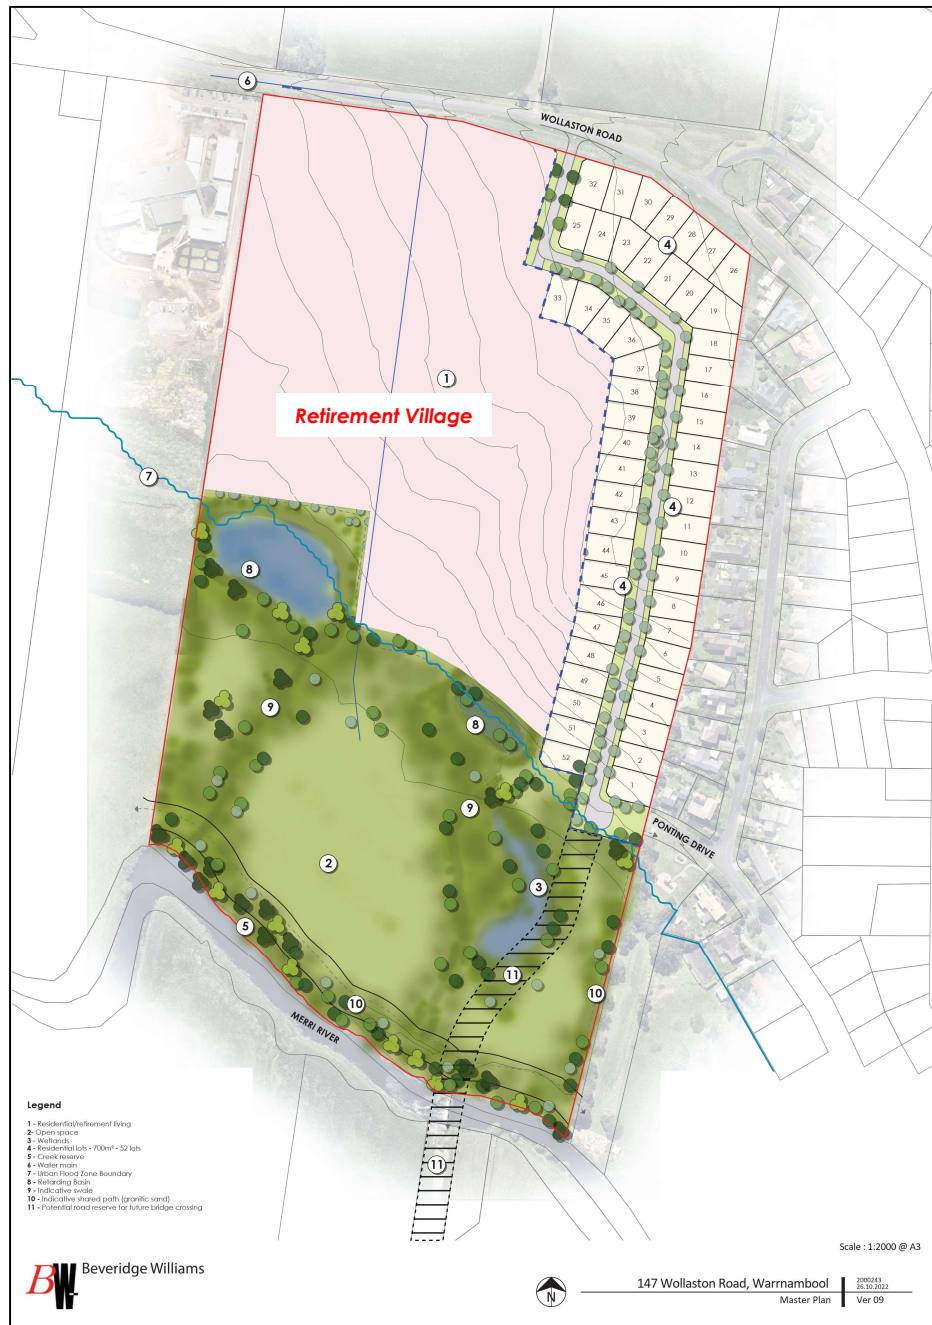
Figure 8: Proposed Development

The proposed development is shown in Figure 8 and attached in Appendix B.

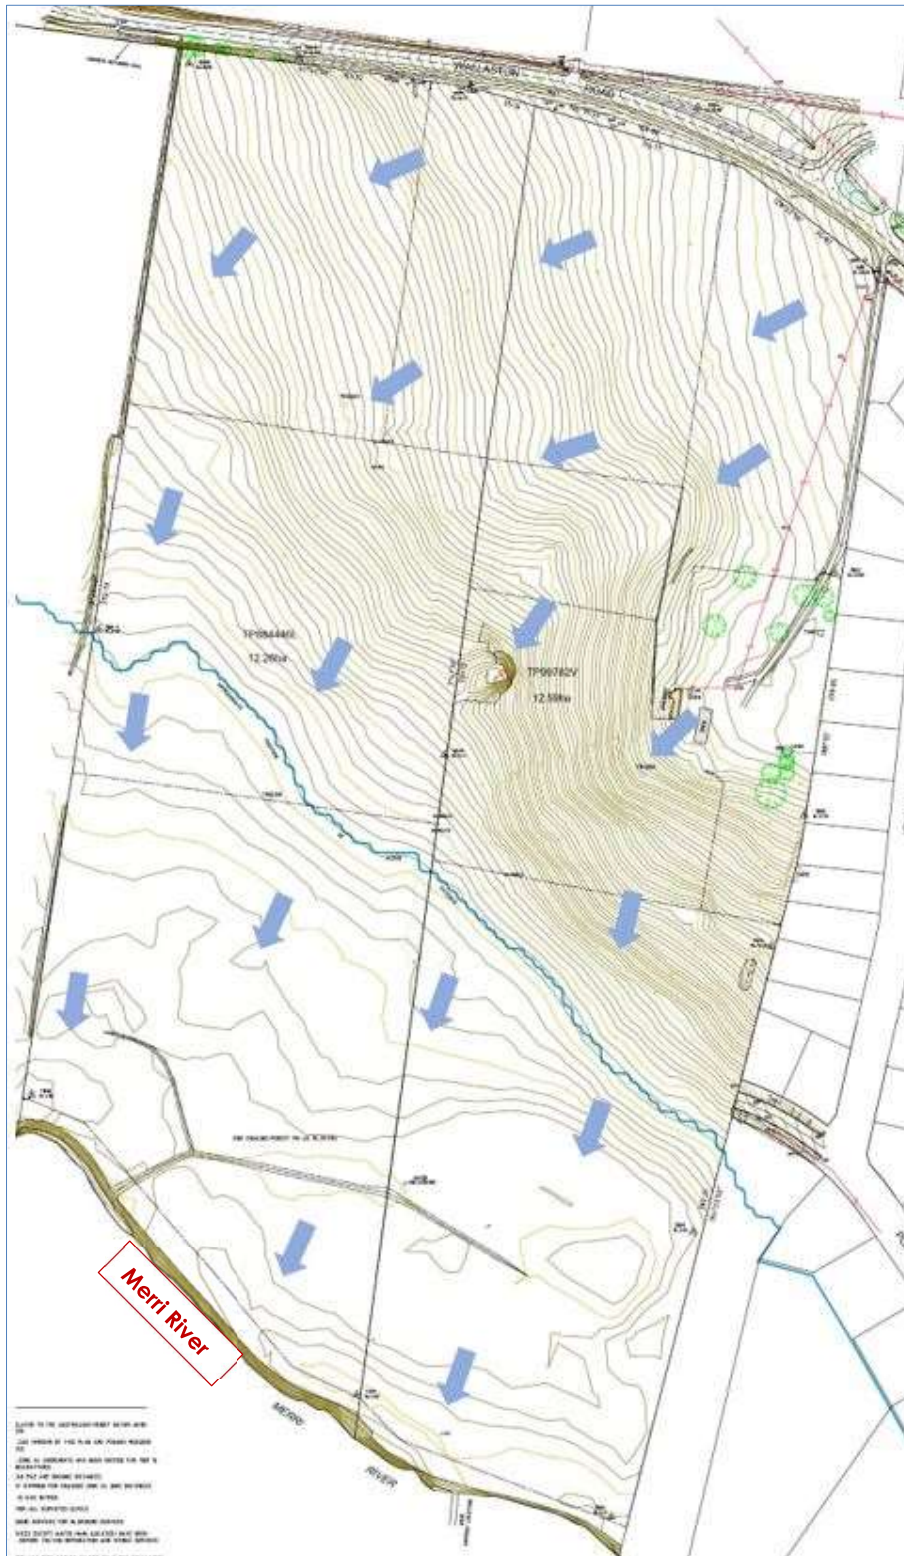
Figure 3: Site Drainage Analysis Plan (Not to scale)

As previously mentioned in Section 2.1, the site generally slopes from north east and north towards to the south. The surface water flows are mainly directed to the Merri River on the south, as shown in Figure 3 below.

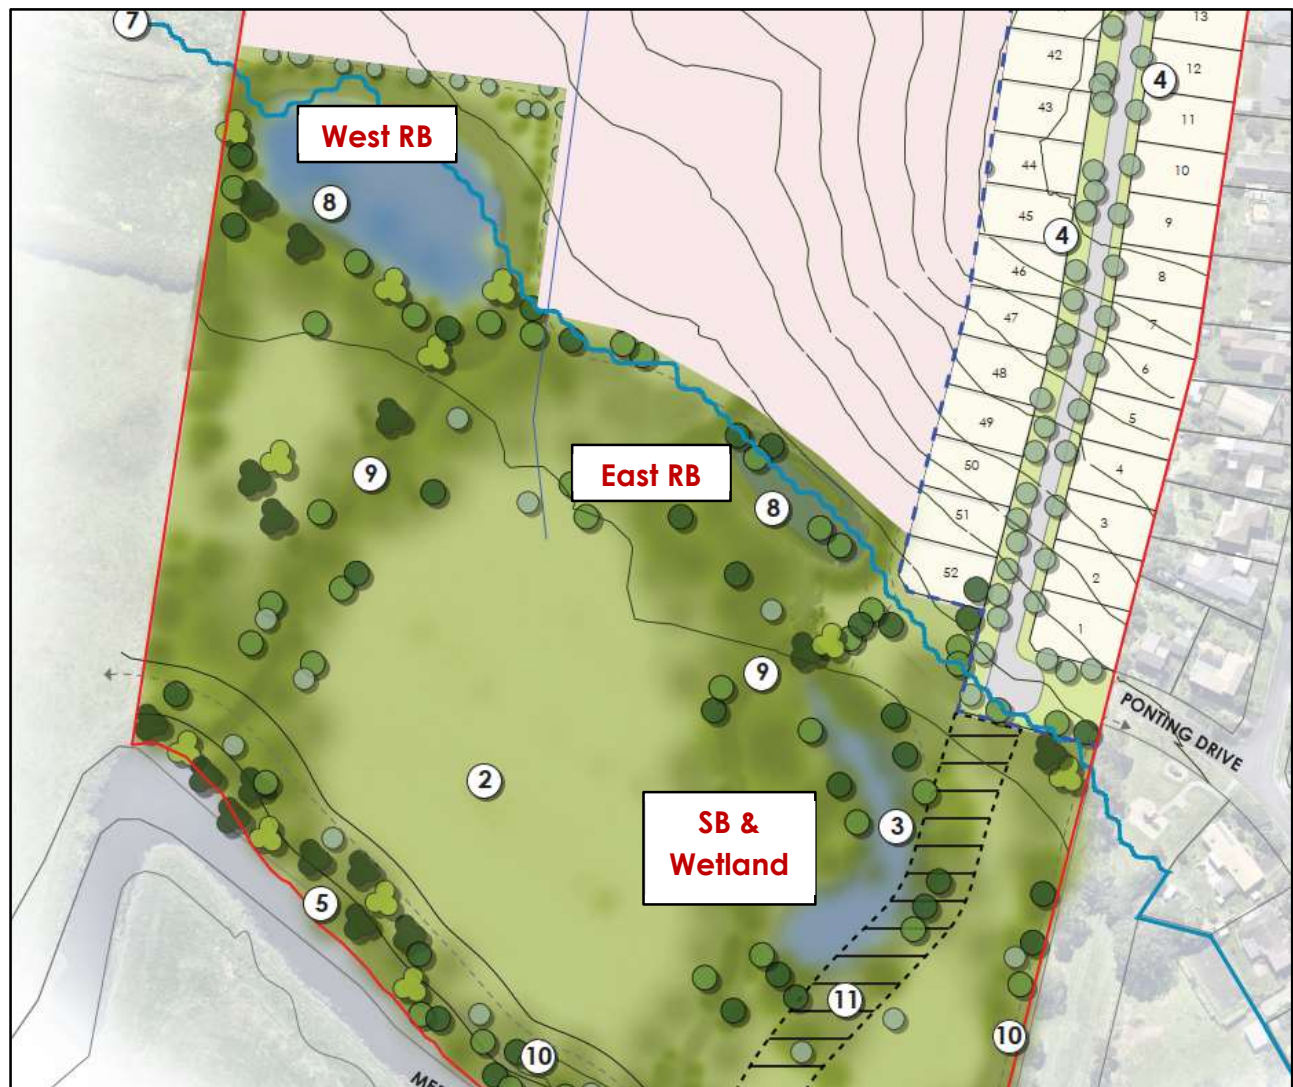
Figure 5: Drainage Assets Location Plan

Details of both stormwater quantity and quality management are discussed in Sections 4 and 5 and Drainage Assets Location Plan is provided in Figure 5 below.

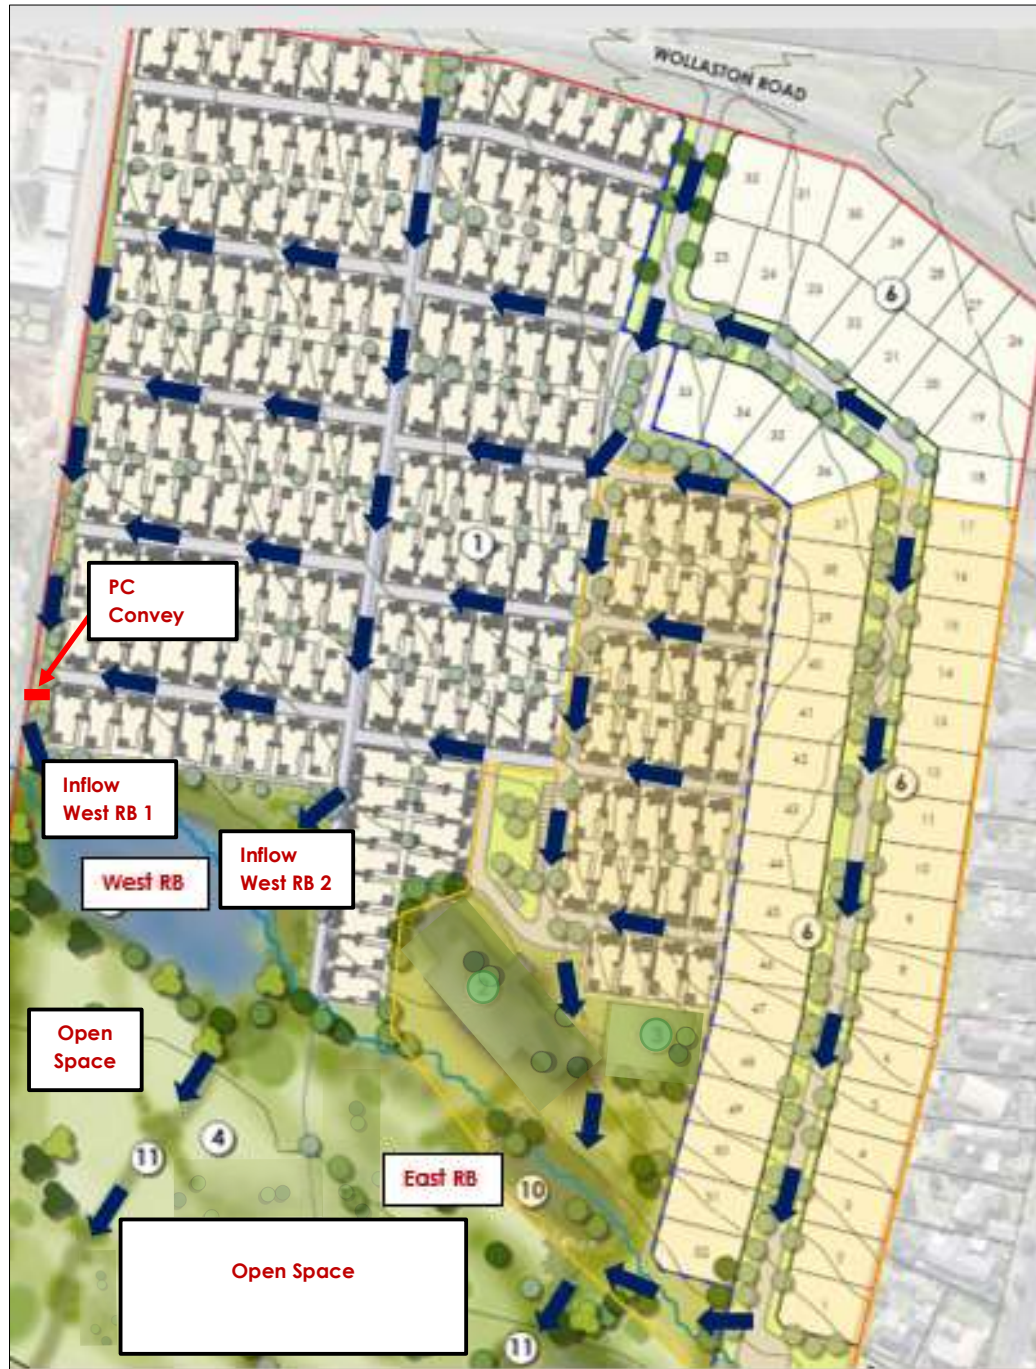
The internal roads for the development, and associated lot finished surface levels, will be designed to ensure that the 1% AEP overland flows through the site are within the safe hydraulic capacity of road floodway.

Figure 10: Indicative Overland Flow Path Plan (based on an Indicative Retirement Village Area Layout) (Not to Scale)

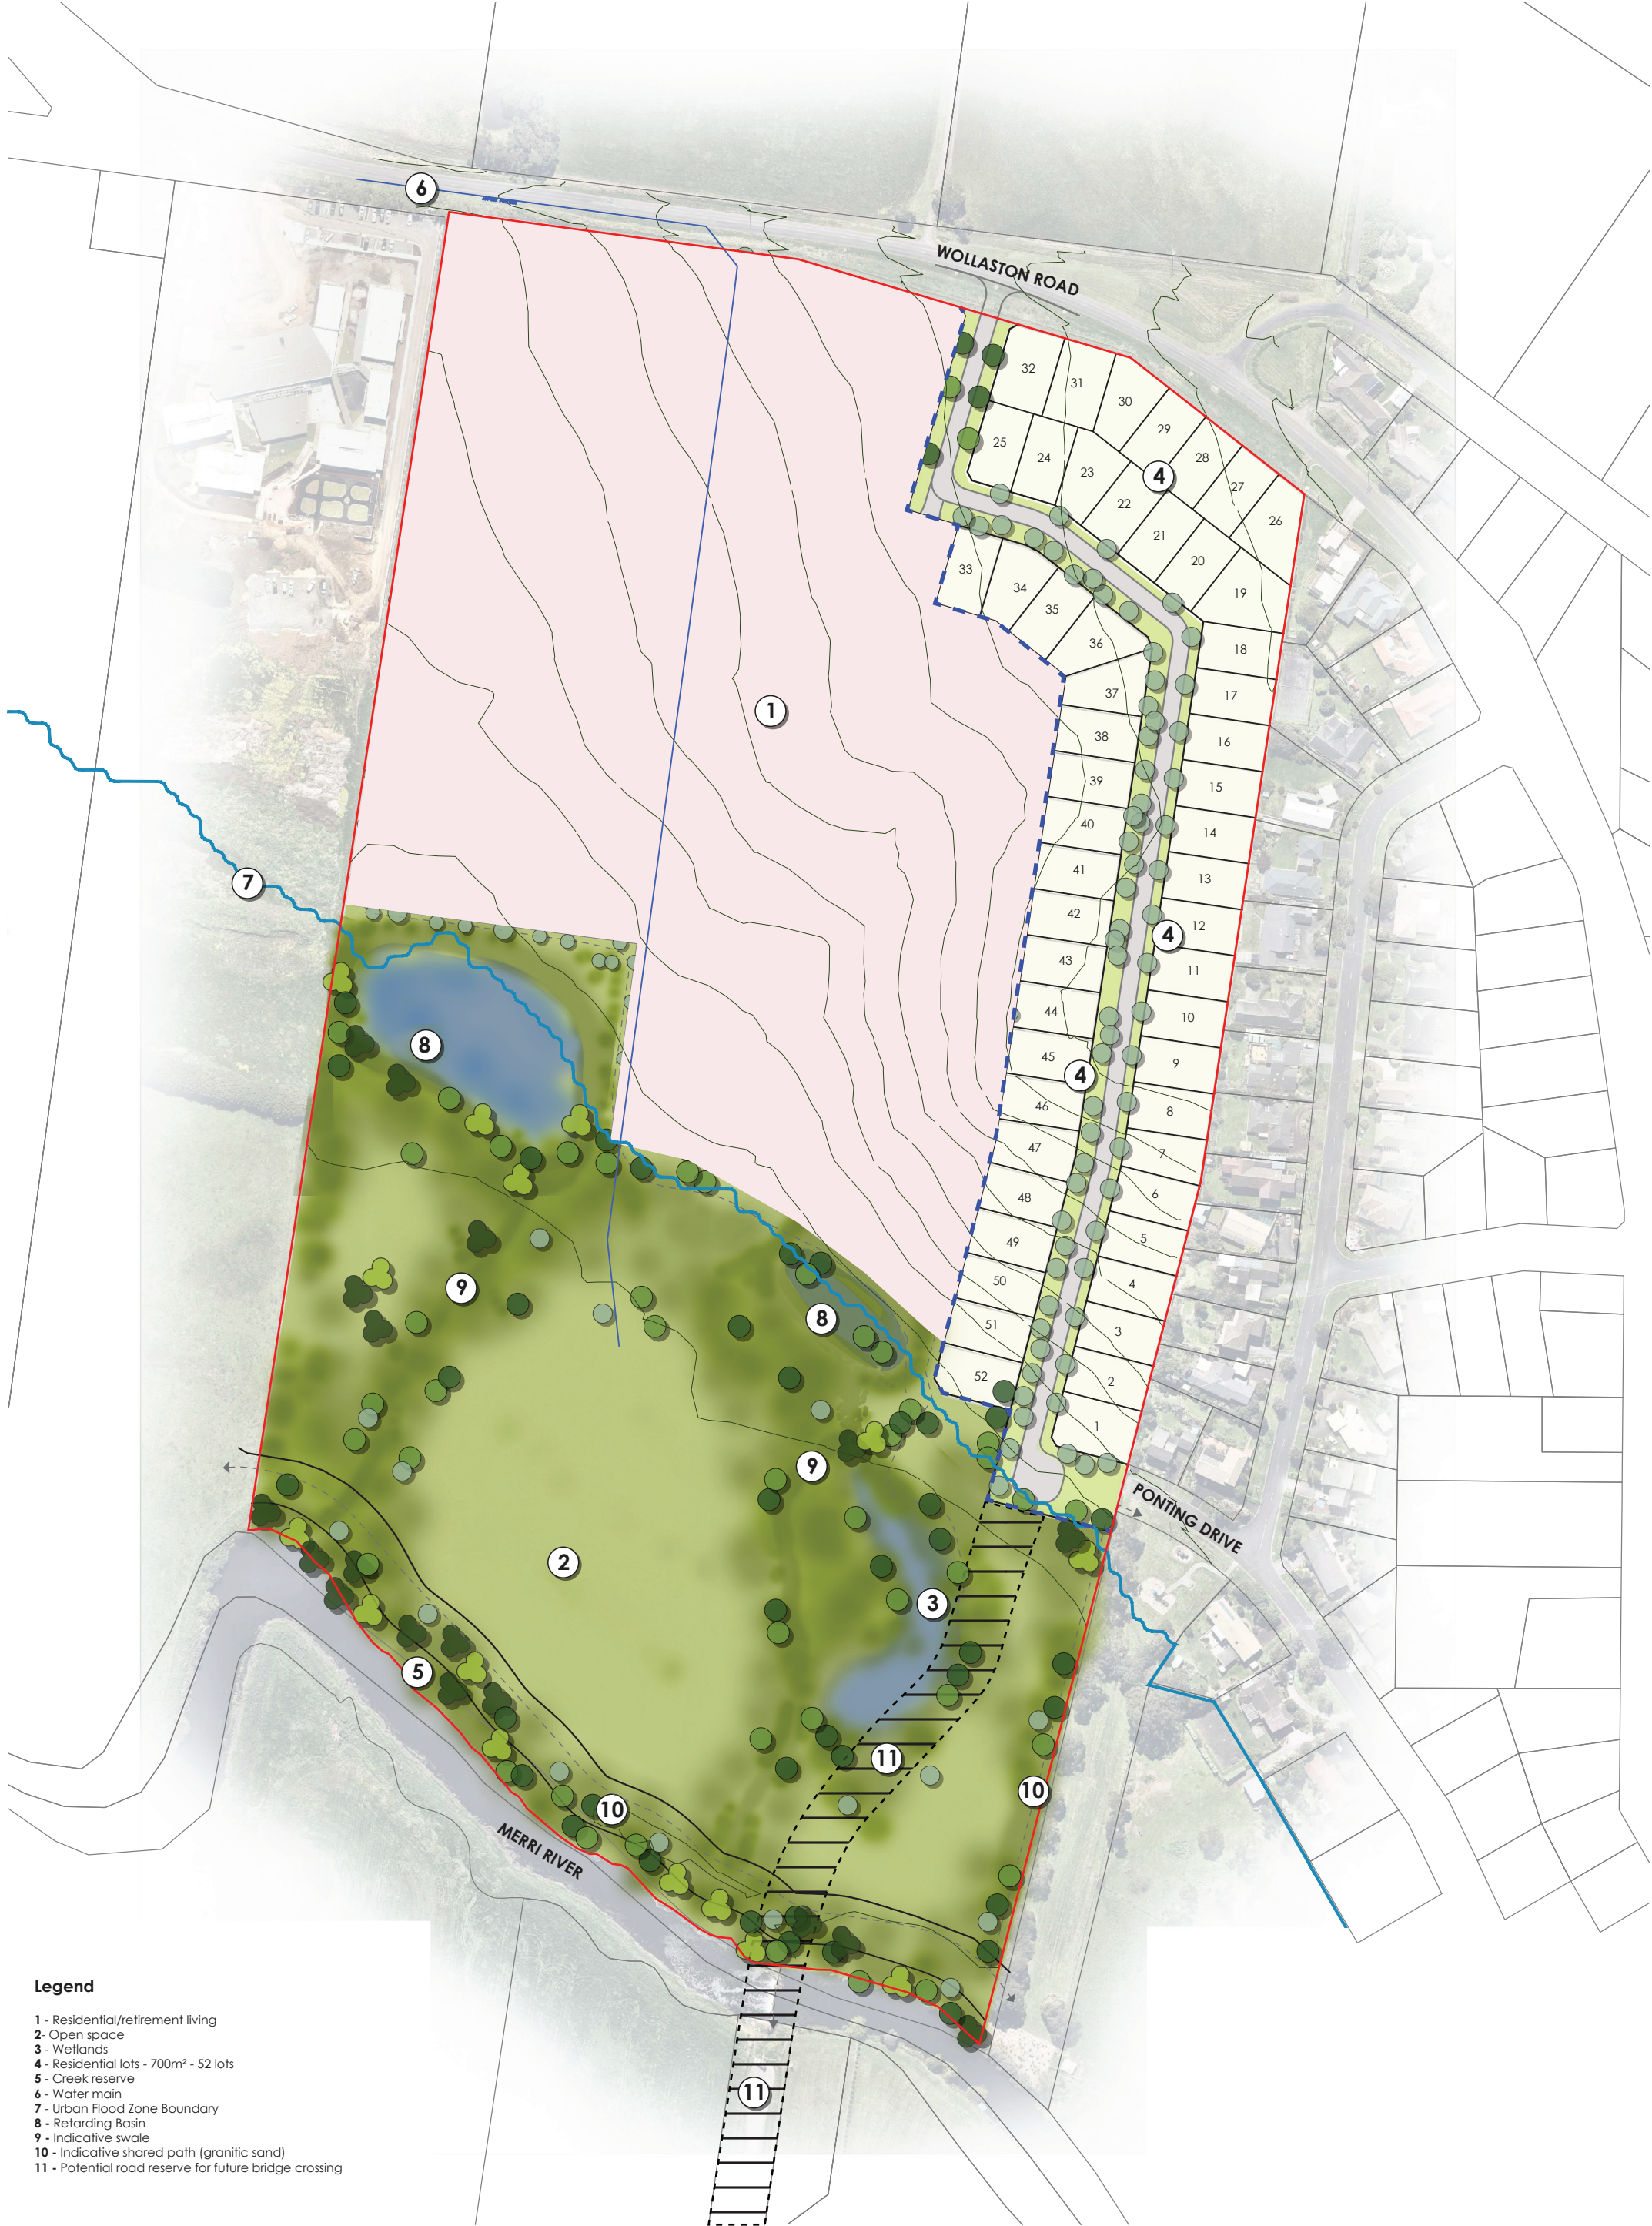
- Legend**
- 1 - Residential/retirement living
  - 2 - Open space
  - 3 - Wetlands
  - 4 - Residential lots - 700m<sup>2</sup> - 52 lots
  - 5 - Creek reserve
  - 6 - Water main
  - 7 - Urban Flood Zone Boundary
  - 8 - Retarding Basin
  - 9 - Indicative swale
  - 10 - Indicative shared path (granitic sand)
  - 11 - Potential road reserve for future bridge crossing

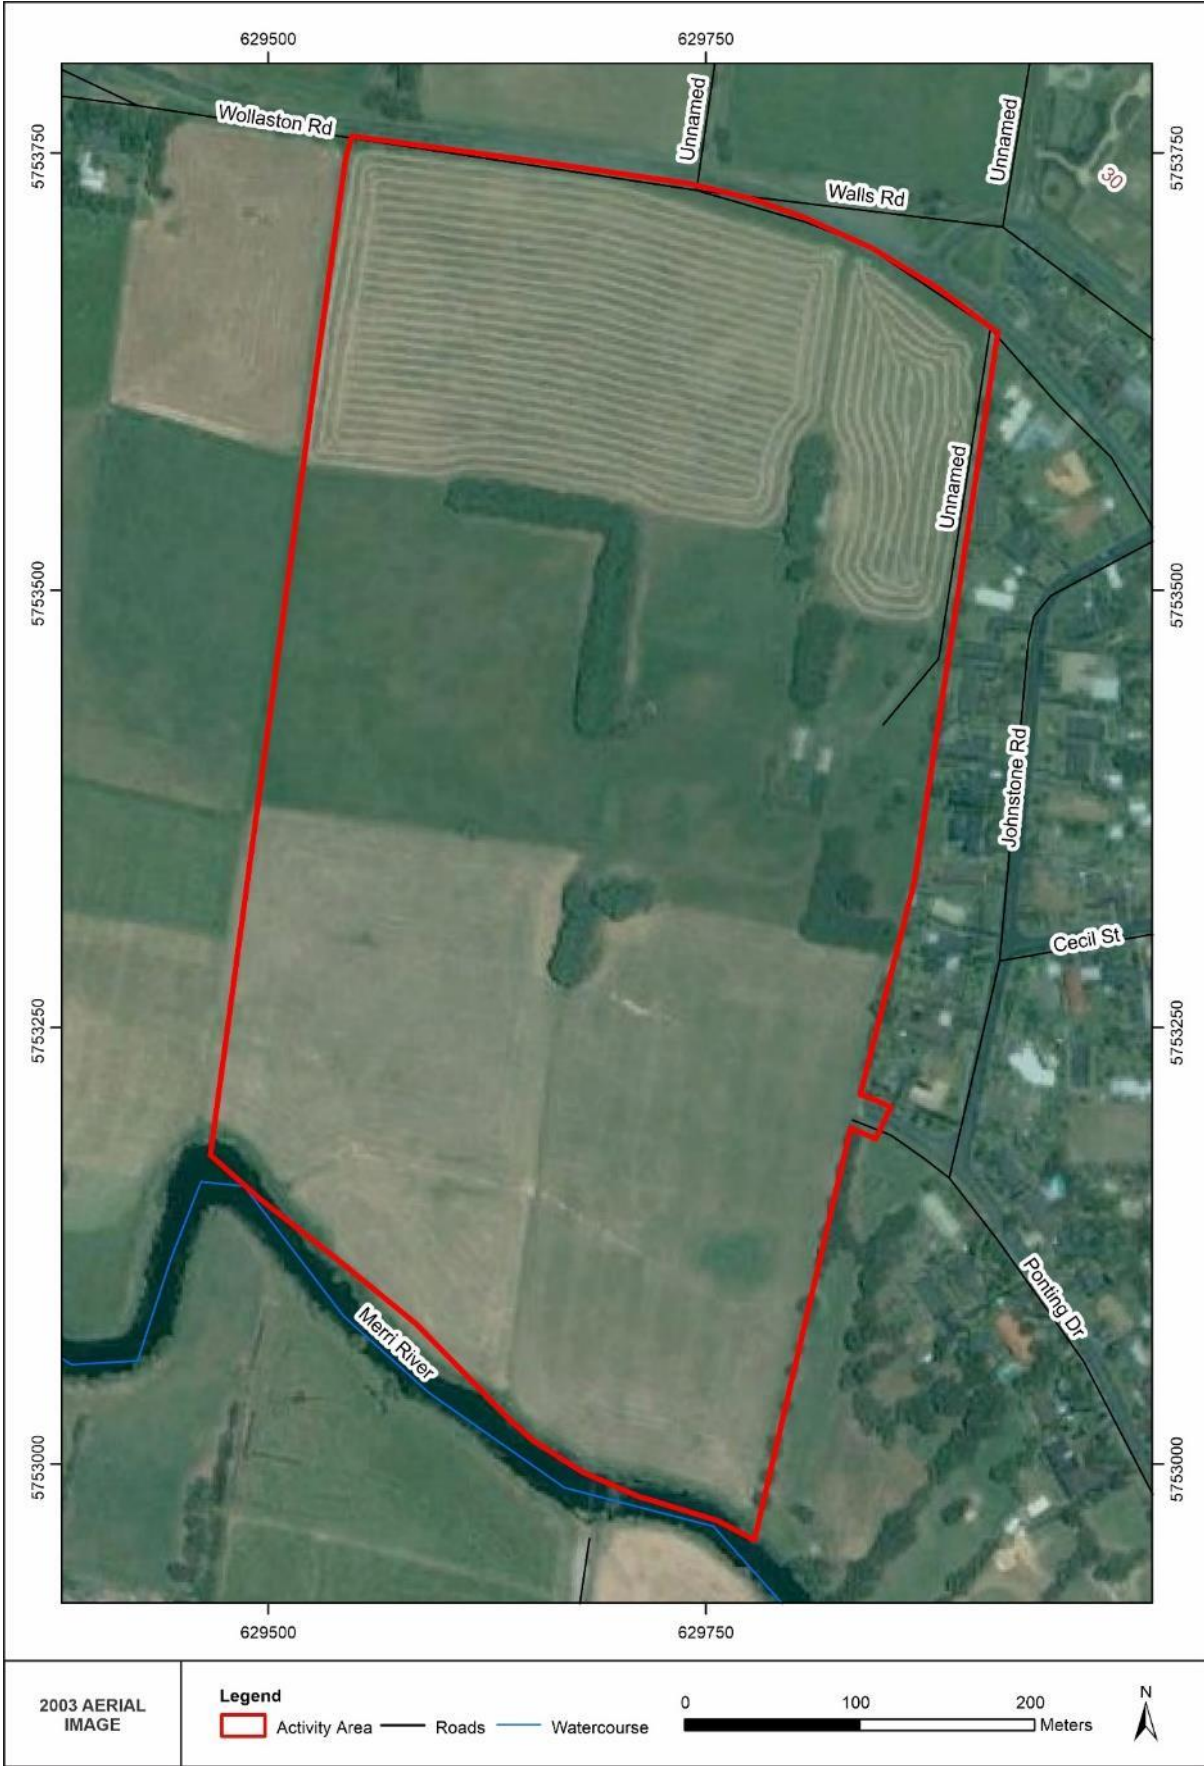
Figure 8: 2003 aerial image (Google Earth)

An aerial image from 2003 (Figure 8) shows large areas of ploughed land in the northern and southern sections of the activity area. The majority of the buildings in the eastern portion have been removed. Established residential areas are evident to the east of the activity area, while the remainder of surrounding properties remain as agricultural land.

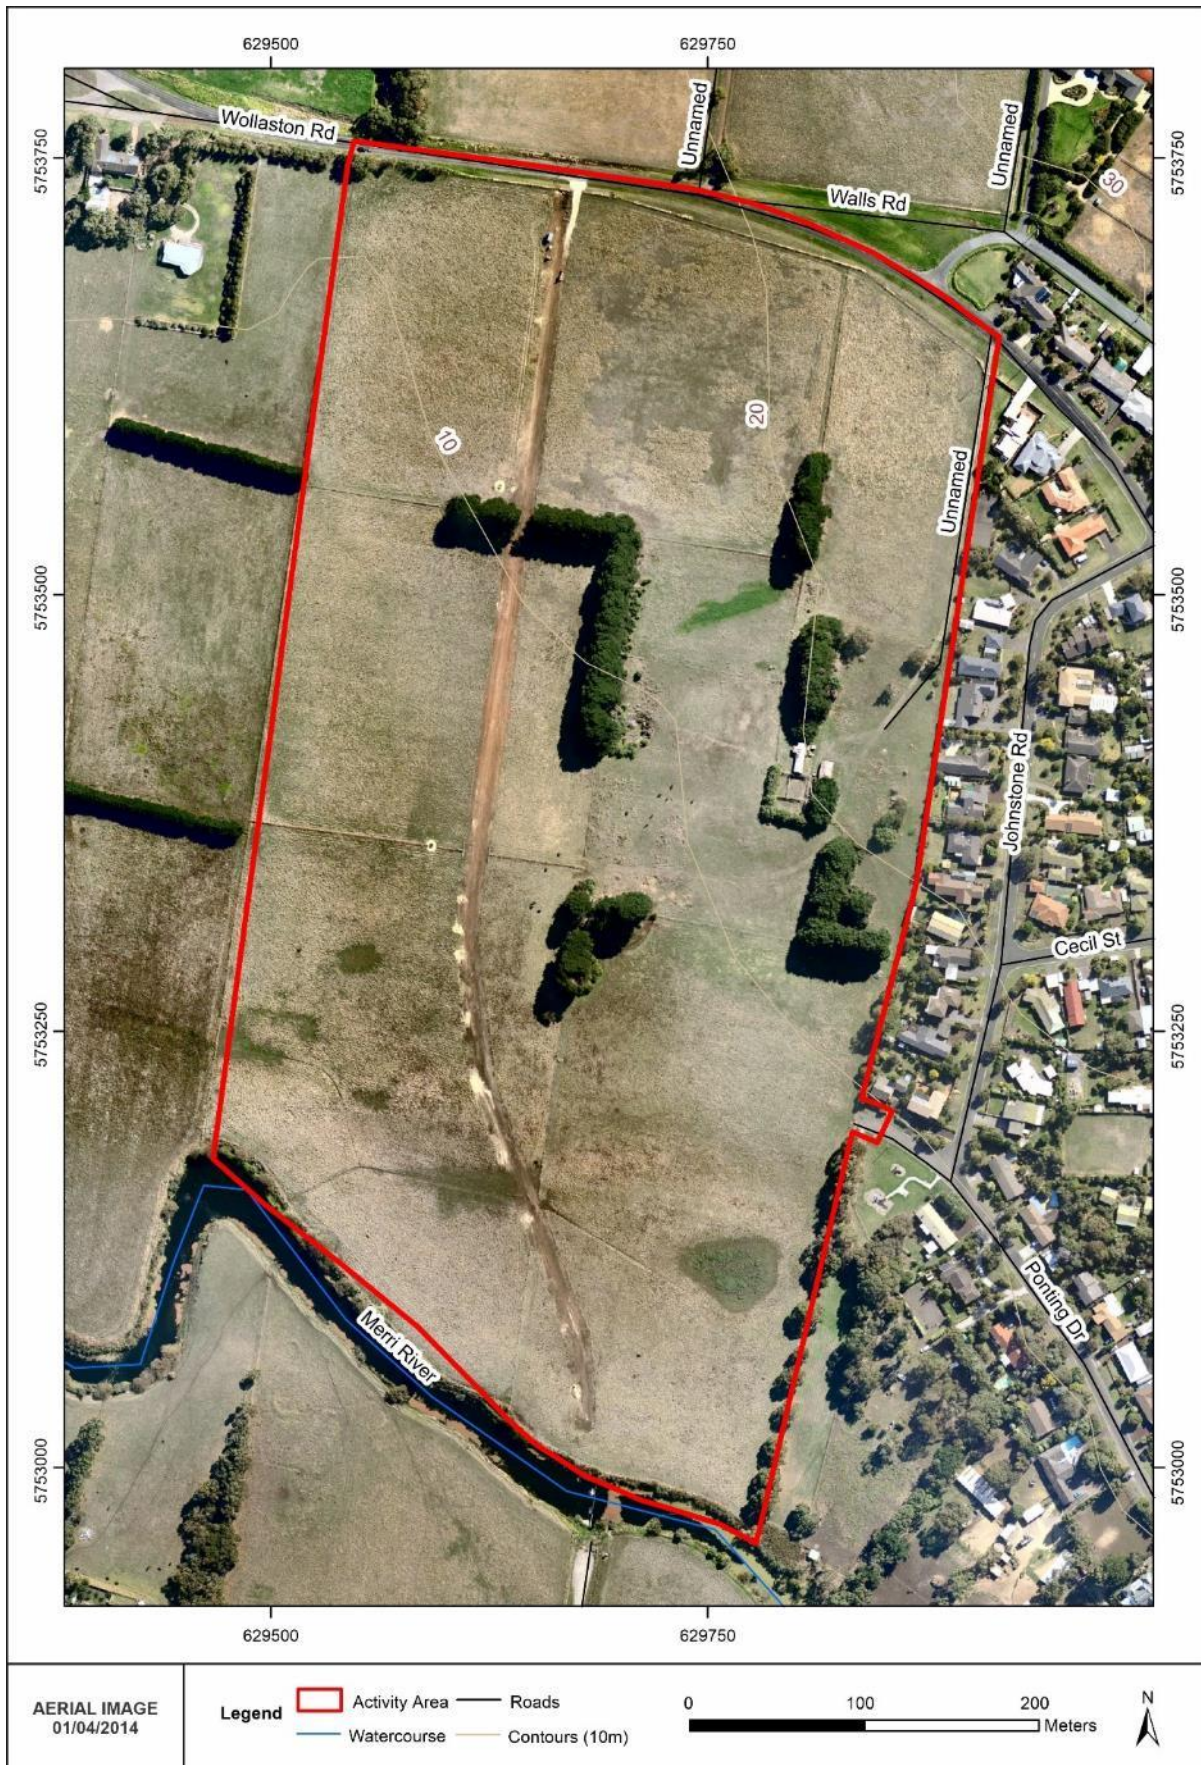
Figure 10: 2014 aerial image (Nearmap)

By 2014 (Figure 10), conditions within the activity area have remained relatively unchanged, with the exception of a track constructed through the centre of the property extending in a north-south direction from Wollaston Road to the weir crossing Merri River. This is most likely associated with the construction of water pipeline installation, as indicated by Dial Before You Dig mapping (DBYD; see below and Figure 12).

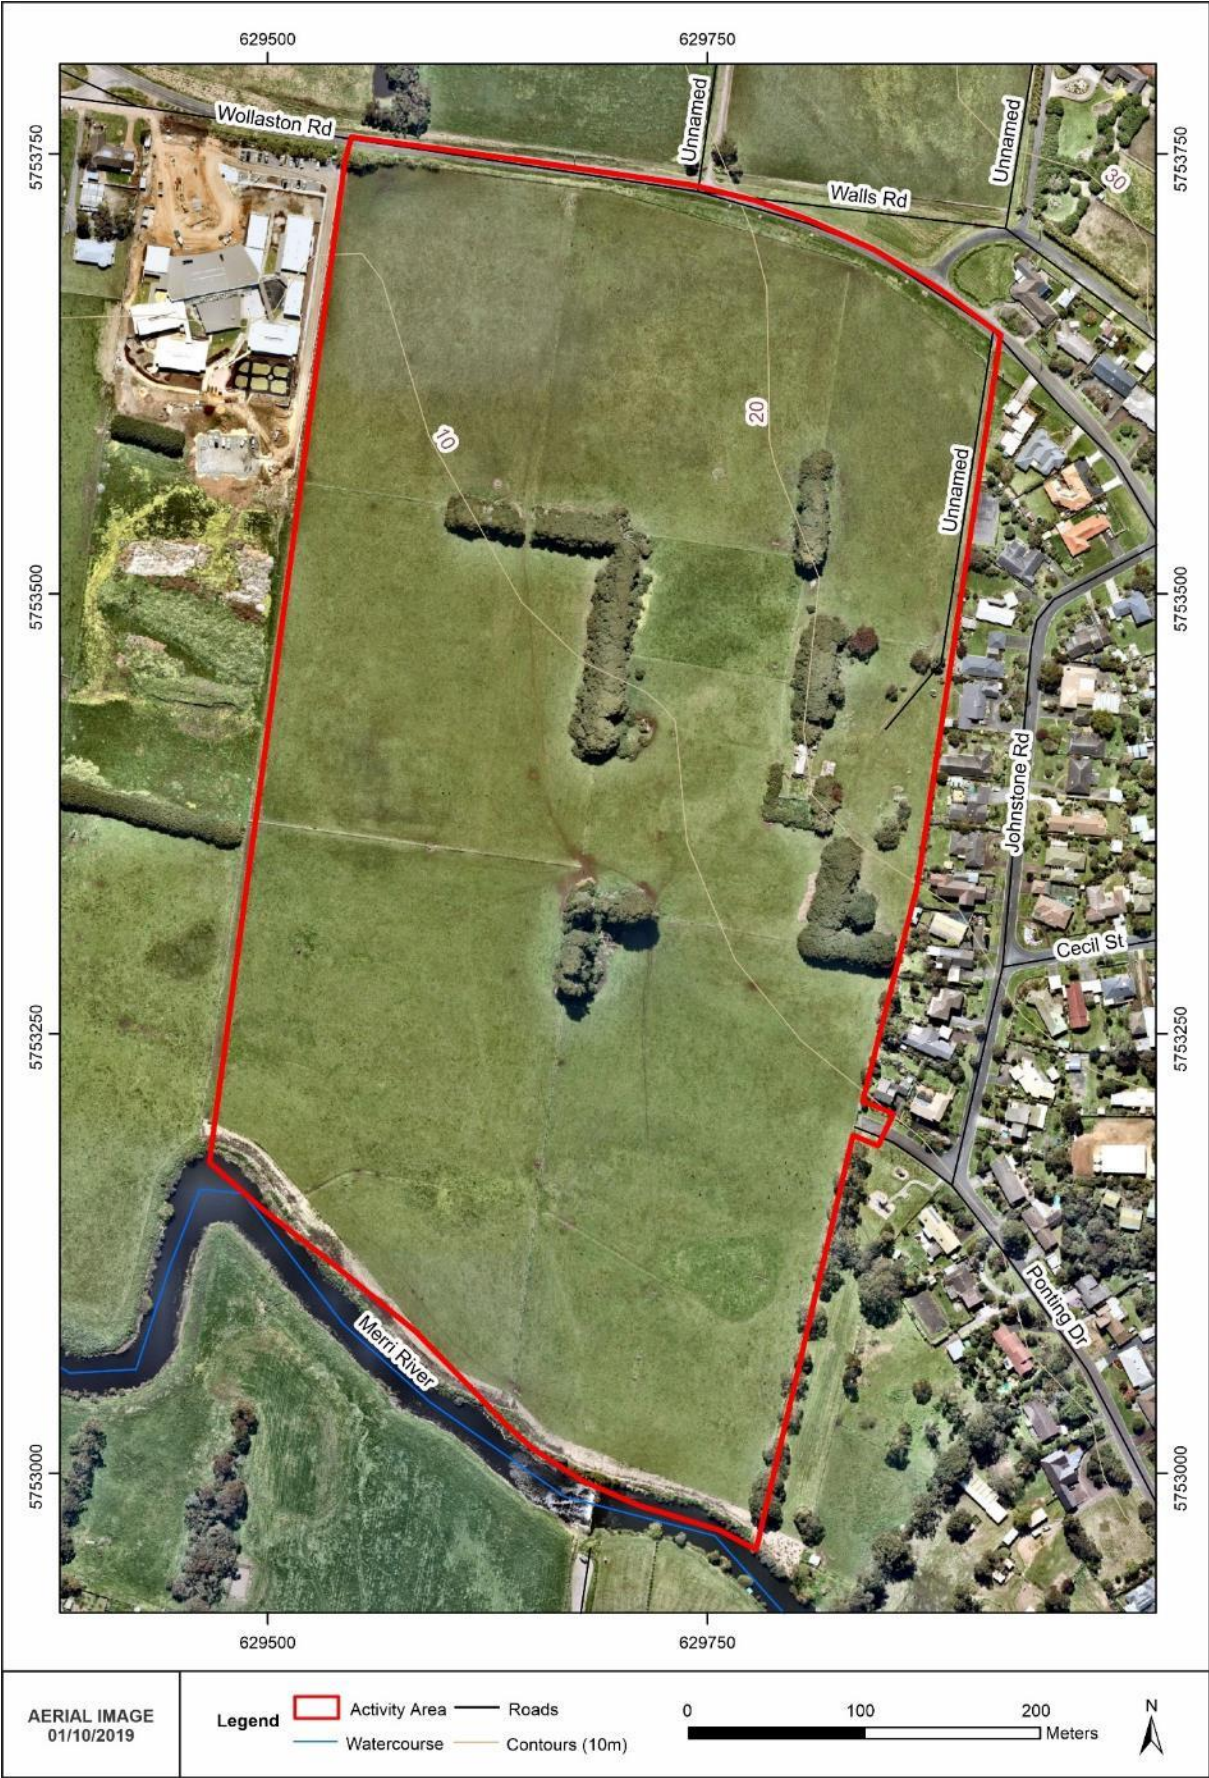
Figure 11: 2019 aerial image (Nearmap)

By 2019 (Figure 11), the track appears to no longer be in use and is covered in vegetation. The 2019 aerial image shows a number of buildings have been constructed in the property to the west of the activity area.

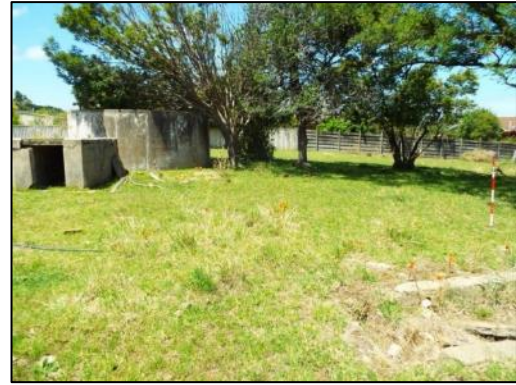
**Plate 8: Concrete structures in SU 2 – facing east**  
(photo by M Reith 11/1/21)

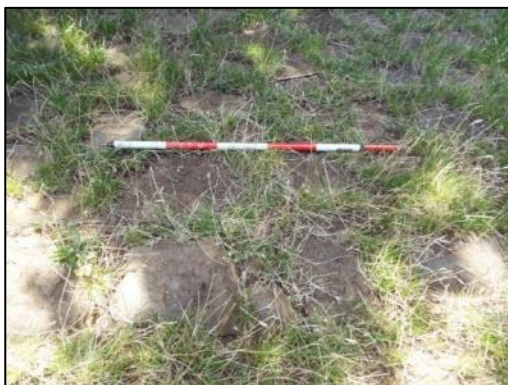
**Plate 9: Basalt boulders used for paving in Area 2 – facing north**  
(photo by M Reith 11/1/21)

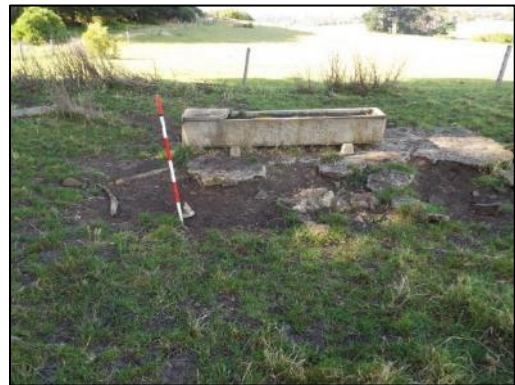
**Plate 16: Water trough showing exposed sediments  
in SU 12 (photo by M Reith 11/1/21)**

Plates 11–16 show conditions in SU 3, 4, 11 and 12. The majority of the area comprised paddocks with uncropped grass and poor ground surface visibility; some areas are evidently used for livestock grazing and cropping of hay. Livestock trampling was noted close to a drinking trough. Areas close to the pine trees show evidence of splash erosion, resulting in some exposed sediments under the dripline.

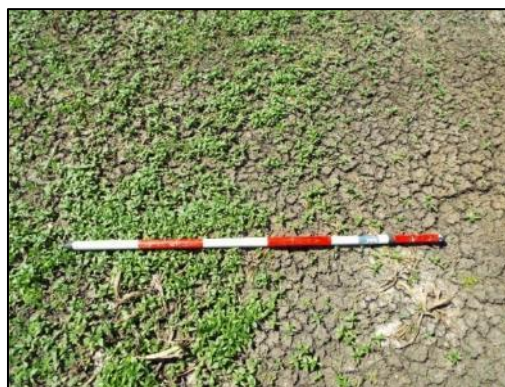
**Plate 22: Exposed sediments in base of dry dam in SU 6 (photo by M Reith 11/1/21)**

Plates 21–26 show conditions in SU 6 and 8, which comprised paddocks with uncropped grass and poor ground surface visibility. Some areas are evidently used for livestock grazing and cropping of hay. The area in and around the dam has some exposed sediments where the water has dried out.

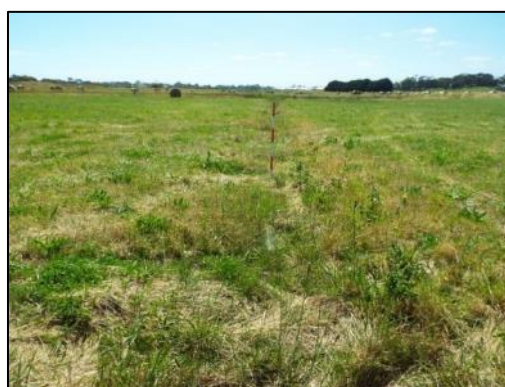
**Plate 24: Facing west drain from dam feeding into Merri River in SU 6 (photo by M Reith 11/1/21)**

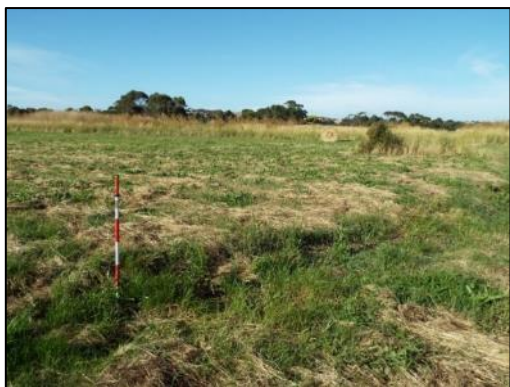
**Plate 25: Facing south drain feeding in Merri River in south of property in SU 8 (photo by M Reith 11/1/21)**

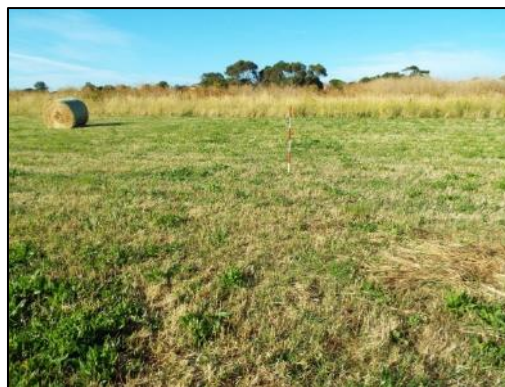
**Plate 26: Facing south drain towards Merri River in SU 8 (photo by M Reith 11/1/21)**

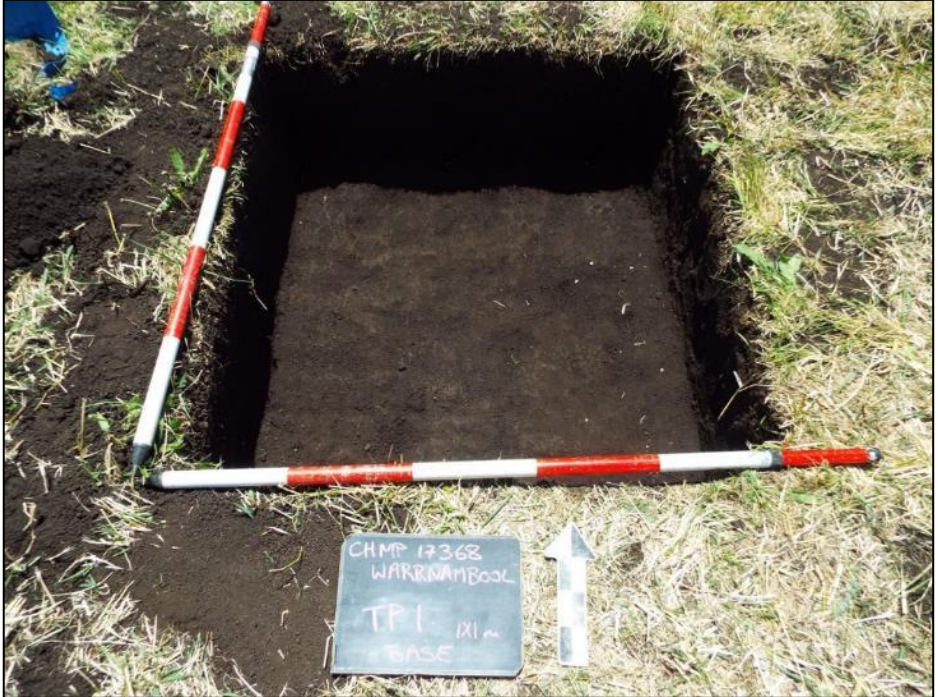
| <p>Test Pit 1 – End of excavation (facing north)</p> <p>(Photo by M Reith 12/1/2021)</p> | |

TP 1 was excavated in the south western corner of the activity area on the flood plain close to Merri River on the mapped Alluvium (Qa1). This test pit contained shallow deposits of friable to compacted very dark greyish-brown silts and silty clays lying over very firmly compacted dark brown clay. No notable inclusions were noted throughout the soil profile, with some bioturbation observed within Context 1. This test pit was excavated to a maximum depth of 360mm. The clay was identified as culturally sterile basal deposits.

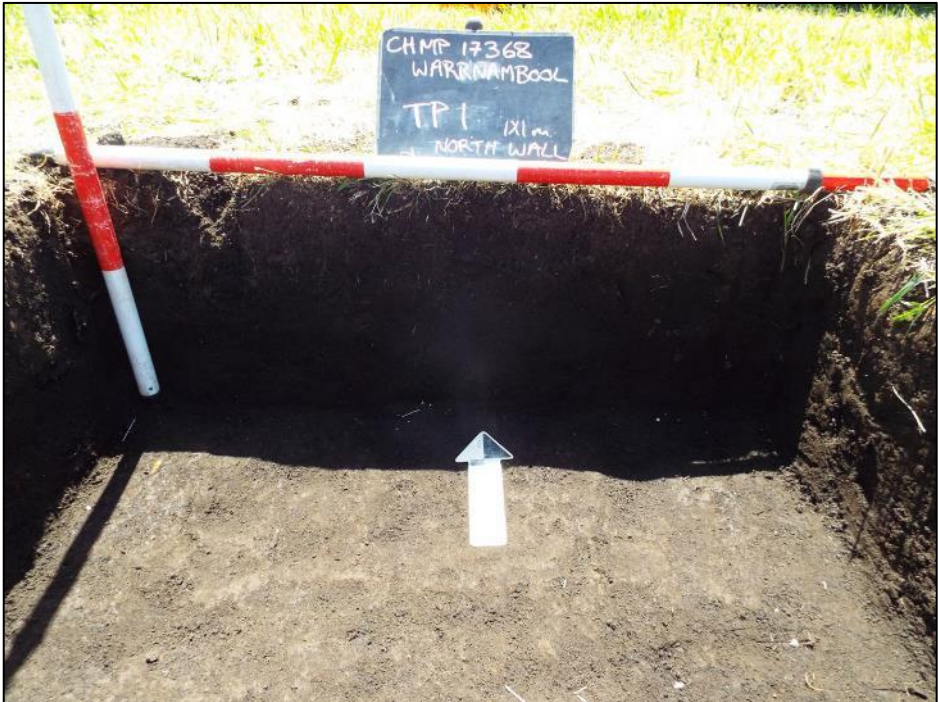
| <p>Test Pit 1 – Close up of stratigraphic profile (facing north)</p> <p>(Photo by M Reith 12/1/2020)</p> | |

| <b>Context 1</b> | 0–80/90mm: Moist friable silt with grass roots and bioturbation. Smooth, diffused transition to Context 2.<br>Munsell: 10YR 3/2 (very dark greyish-brown), pH: 6.5. | | |

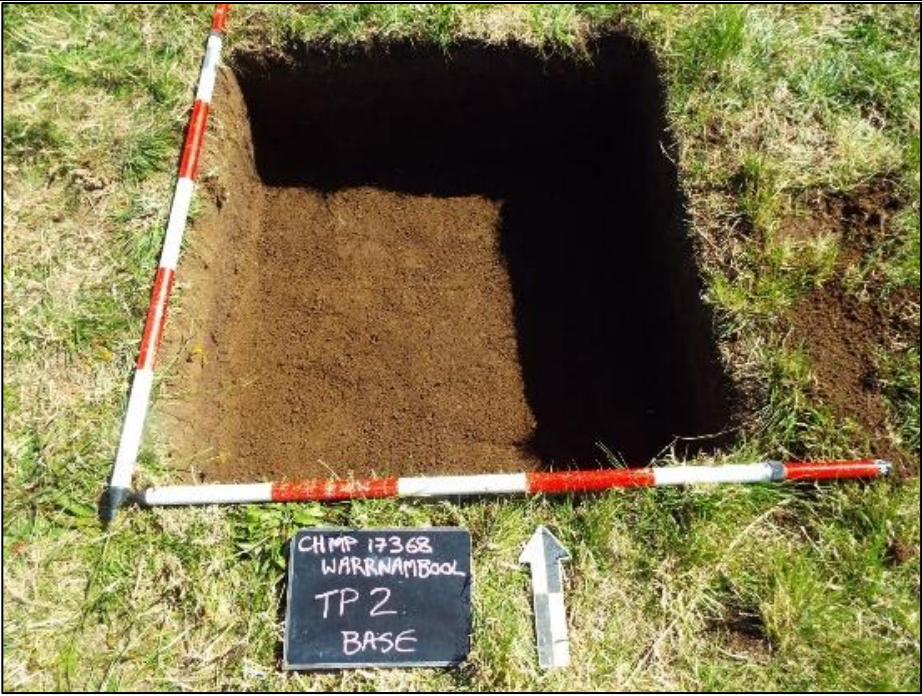
| <b>Test Pit 2 – End of excavation (facing north)</b><br><br><b>(Photo by M Reith 14/1/2021)</b> | | | |

TP 2 was placed in the western-central part of the activity area on the mapped Tower Hill Tuff (Nept) geology. This test pit contained shallow deposits of friable to compact dark brown silts, dark brown clayey silts and very dark brown silty clays lying over strongly compacted dark brown clay. Inclusions of rounded 'buckshot' (pisolite) were noted throughout much of the lower part of the soil profile, with a higher accumulation at the boundary with the basal clay. The presence of pisoliths is indicative of retarded drainage. This test pit was excavated to a maximum depth of 400mm. The clay was identified as culturally sterile basal deposits.
