# Traffic Impact Assessment

147 WOLLASTON ROAD,  
WARNAMBOOL

Development Plan Appendices - 147 Wollaston Road Warrnambool  
Approved 5 December 2022

Client: Gull Group  
 Issued: 4/11/2022  
 Version: 2.0  
 Prepared by: Max Small  
 Checked by: Jimmy Liakos  
 Project Manager: Antonia Erceg  
 Project Number: 2000243

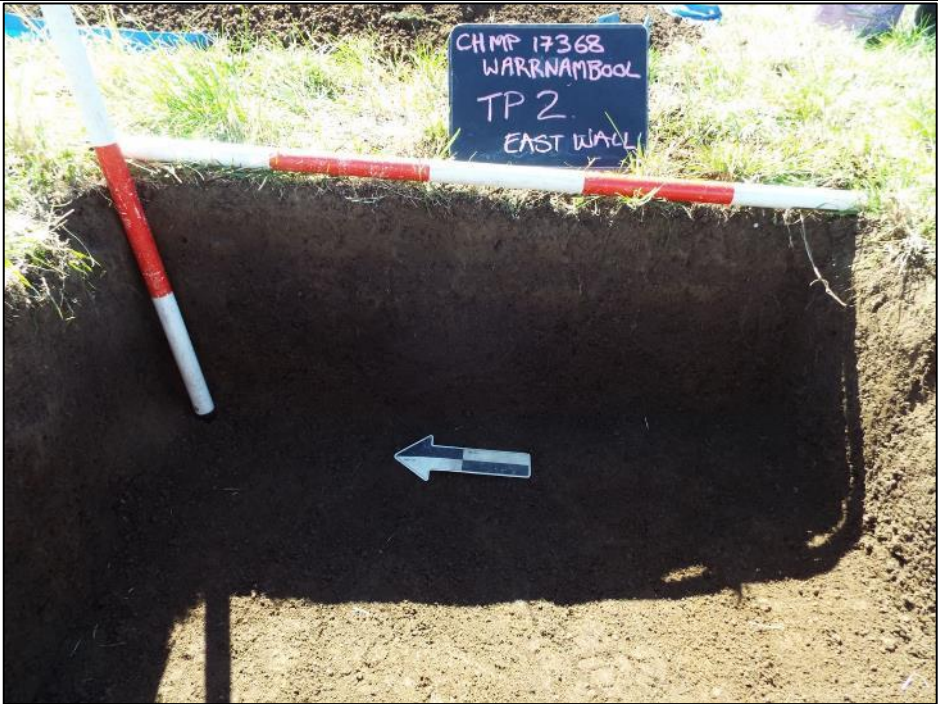
Test Pit 2 – Close up  
of stratigraphic  
profile (facing east)

| <b>Context 1</b> | 0–80/140mm: Moist, friable silt with grass root inclusion and bioturbation. Smooth, diffused transition to Context 2.<br>Munsell: 7.5YR 3/2 (dark brown), pH: 6.5. | | |
| <b>Context 2</b> | 80/140–210/280mm: Moist, friable clayey silt with buckshot inclusions. Smooth and diffuse transition with Context 3.<br>Munsell: 7.5YR 3/2 (dark brown), pH: 6.5. | | |
| <b>Context 3</b> | 210/280–310/340mm: Moist, compact silty clay with frequent buckshot inclusion. Smooth and diffuse transition with Context 4.<br>Munsell: 7.5YR 2.5/3 (very dark brown), pH: 6.5. | | |
| <b>Context 4</b> | 310/340–340/400mm: Moist, highly compact clay with some buckshot inclusion.<br>Munsell: 7.5YR 3/3 (dark brown), pH: 6. | | |

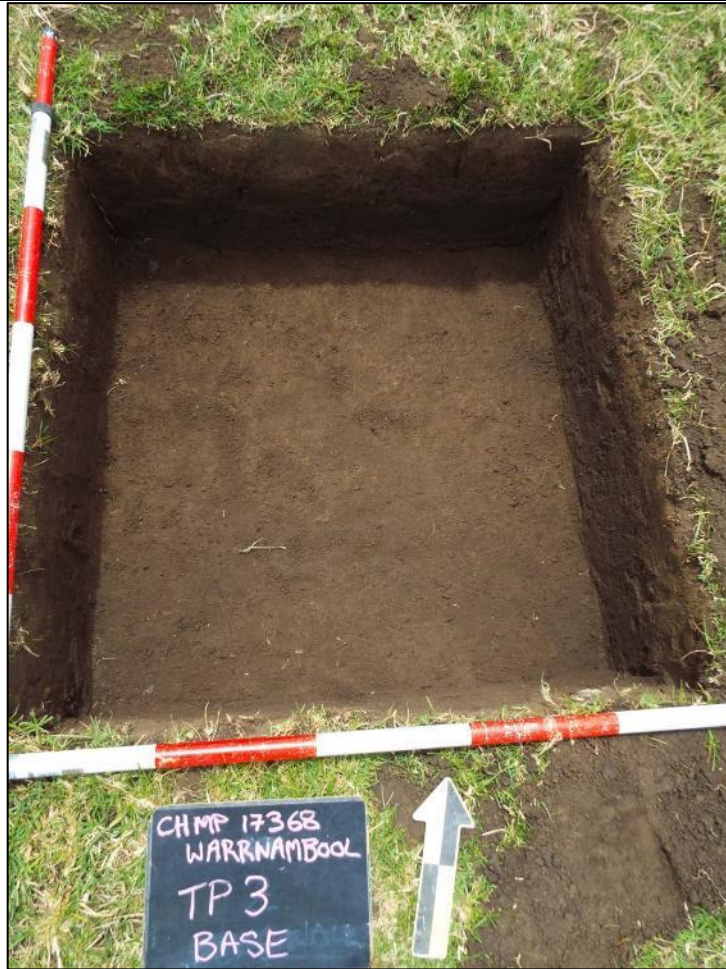
Test Pit 3 – End of  
excavation (facing  
north)

TP 3 was situated on Port Campbell Limestone (Nhp) in the north eastern quadrant of the activity area. This test pit contained shallow deposits of friable dark brown silty loam and dark greyish-brown silty clay lying over firmly compacted very dark brown clay. Inclusions of rare limestone pebbles in Context 2. Inclusions of rounded ‘buckshot’ (pisolite) were noted throughout much of the lower part of the soil profile, with a slightly higher accumulation at the boundary with the basal clay. The presence of pisoliths is indicative of retarded drainage. This test pit was excavated to a maximum depth of 360mm. The clay was identified as culturally sterile basal deposits.

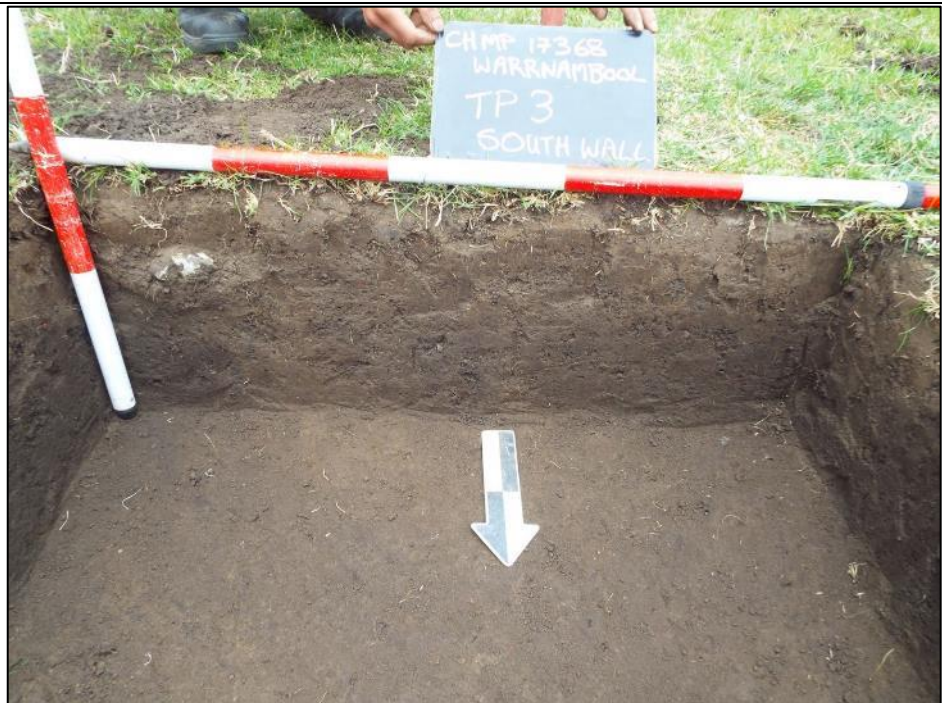
Test Pit 3 – Close up  
of stratigraphic  
profile (facing south)

| <b>Context 1</b> | 0–120mm: Moist, friable silty loam with abundant small rootlets. Smooth and diffuse transition with Context 2. Munsell: 10YR 3/3 (dark brown), pH: 6. | | |
| <b>Context 2</b> | 120–320/340: Moist, moderately compacted silty clay with rare sub-rounded degraded limestone cobbles (~100mm) and uncommon fine rounded buckshot inclusions. Smooth and diffuse transition with Context 3. | | |
| <b>Context 3</b> | Munsell: 10YR 3/2 (very dark greyish-brown), pH: 6.<br><br>320/340–360mm: Moist, firmly compacted clay with uncommon fine rounded buckshot inclusions.<br>Munsell: 10YR 2/2 (very dark brown), pH: 6. | | |

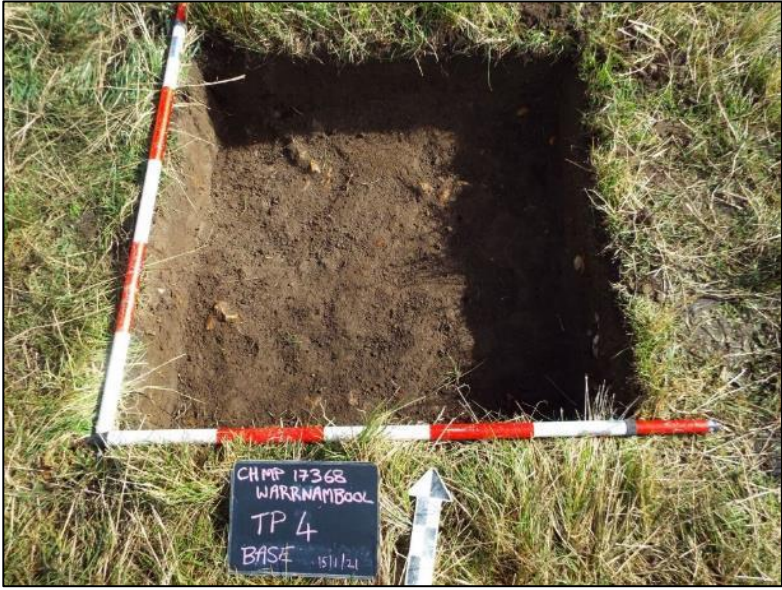
| <p>Test Pit 4 – End of excavation (facing north)</p> <p>(Photo by M Reith<br/>15/1/2021)</p> | |

TP 4 was placed in the north eastern corner of the activity area on the mapped Newer Volcanic Group – basalt flows (Neo). This test pit contained shallow deposits of compact dark brown clayey silts and firmly compacted dark brown silty clays lying over strongly compacted very dark brown clay. Inclusions of sub-angular degraded basalt were observed within Contexts 2 and 3. This test pit was excavated to a maximum depth of 310mm. The clay was identified as culturally sterile basal deposits.

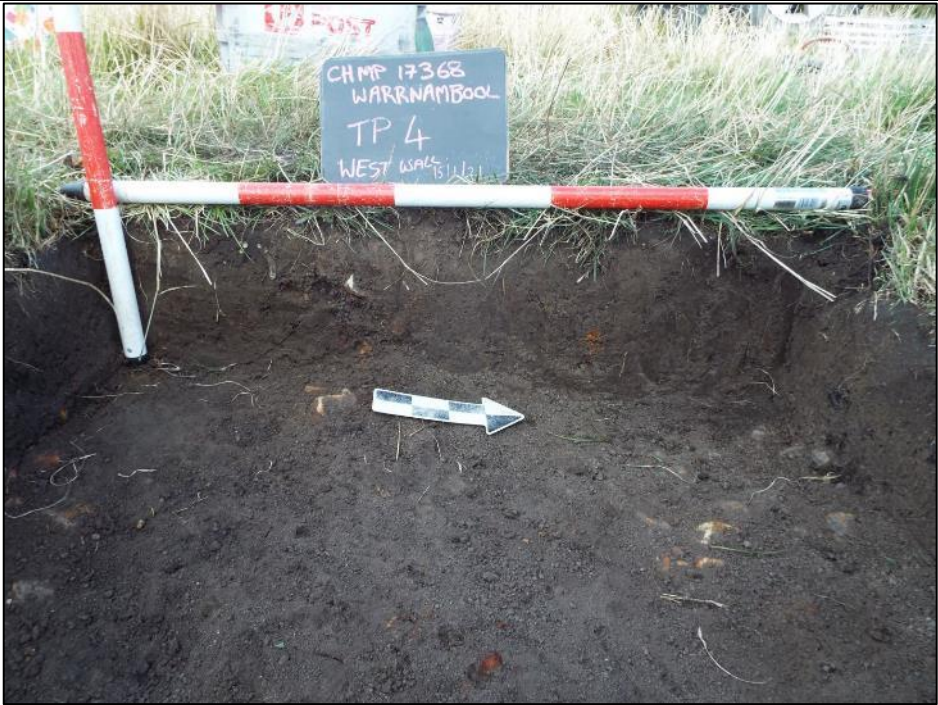
| <p>Test Pit 4 – Close up of stratigraphic profile (facing west)</p> <p>(Photo by M Reith<br/>15/1/2021)</p> | |

| <b>Context 1</b> | 0–50mm: Moist, compact clayey silt with grass roots and bioturbation. Smooth and diffuse transition with Context 2. Munsell: 7.5YR 3/2 (dark brown), pH: 6. | | |
| <b>Context 2</b> | 50–210/280mm: Moist, firmly compacted silty clay with uncommon degraded, sub-angular medium sized (~50–150mm) basalt inclusions throughout. Smooth and diffuse transition with Context 3. Munsell: 7.5YR 3/2 (dark brown), pH: 6. | | |
| <b>Context 3</b> | 210/280–220/310mm: Moist, strongly compacted clay with rare degraded, sub-angular, medium sized (~50–150mm) basalt inclusions.<br>Munsell: 7.5YR 2.5/3 (very dark brown), pH: 6. | | |

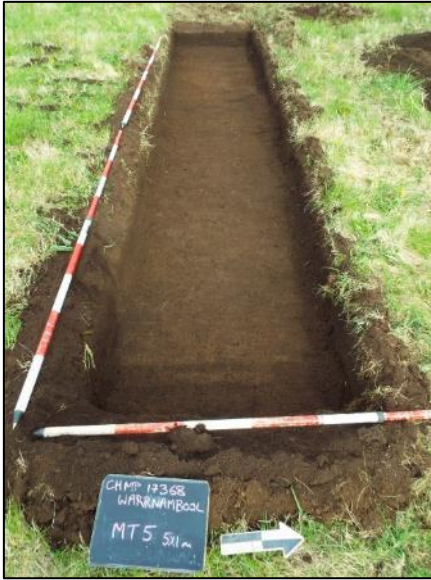
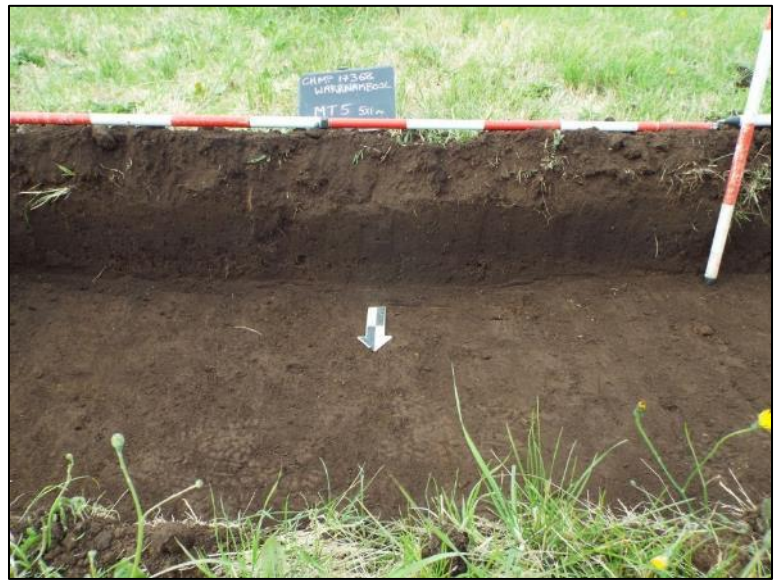
| Machine Trench 5 | | |
|---|---|---|
| <div><h3>MACHINE TRENCH 5</h3><h3>SOUTH WALL</h3><p>Length (mm)</p><p>0 1000 2000 3000 4000 5000</p><p>Depth (mm)</p><p>0 200 400</p><p>1 3 2 4 Unexcavated 4</p></div> | | |

The soil horizons recorded within MTs 2, 4 and 5 (described as very dark brown, or very dark grey clayey silts and silty clays) are comparable in soil composition, consistency and chemical makeup to TP 3. The sediments were noted to be moist at the time of excavation with occasional ‘buckshot’ and limestone inclusions. Basal deposits consisted of very dark brown, dark brown or dark reddish-brown compact clay. Modern glass was recovered from Context 1 (0–100mm) in MT 2.

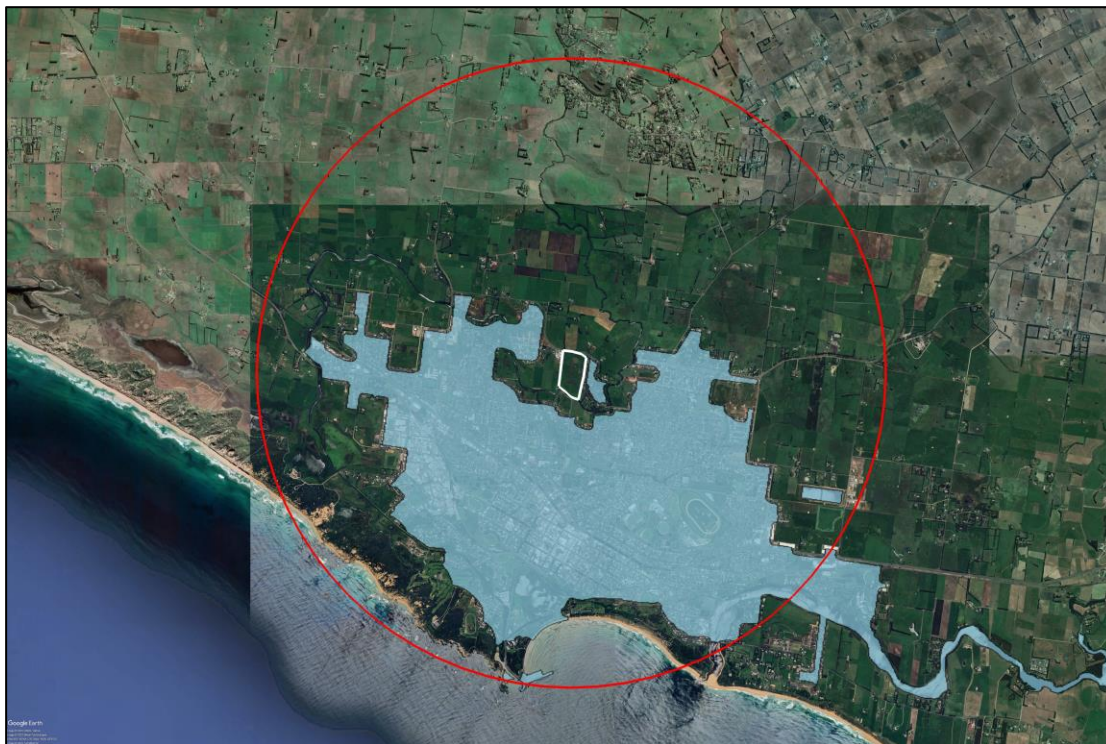
Seven machine transects (MTs), measuring 1x5m, were excavated across the activity area (Map 9). These focused on particular landform elements: simple slopes (MTs 2A, 3, 4 and 5), lower waning slope (MT 3), flat (MT 7) and crest (MT 1) part of the activity area.

**Figure 1 – 147 Wollaston Road area (site shown in white outline, 5km buffer in red outline) non-BPA land is shown in teal shading (2022 Google Earth).**

The site comprises a large vacant lot north of the progressively developing urban areas of Warrnambool in the City of Warrnambool local government area (see Figure 1). The site is in the south-eastern corner of the North of Merri River Structure Plan (Mesh, 2011).

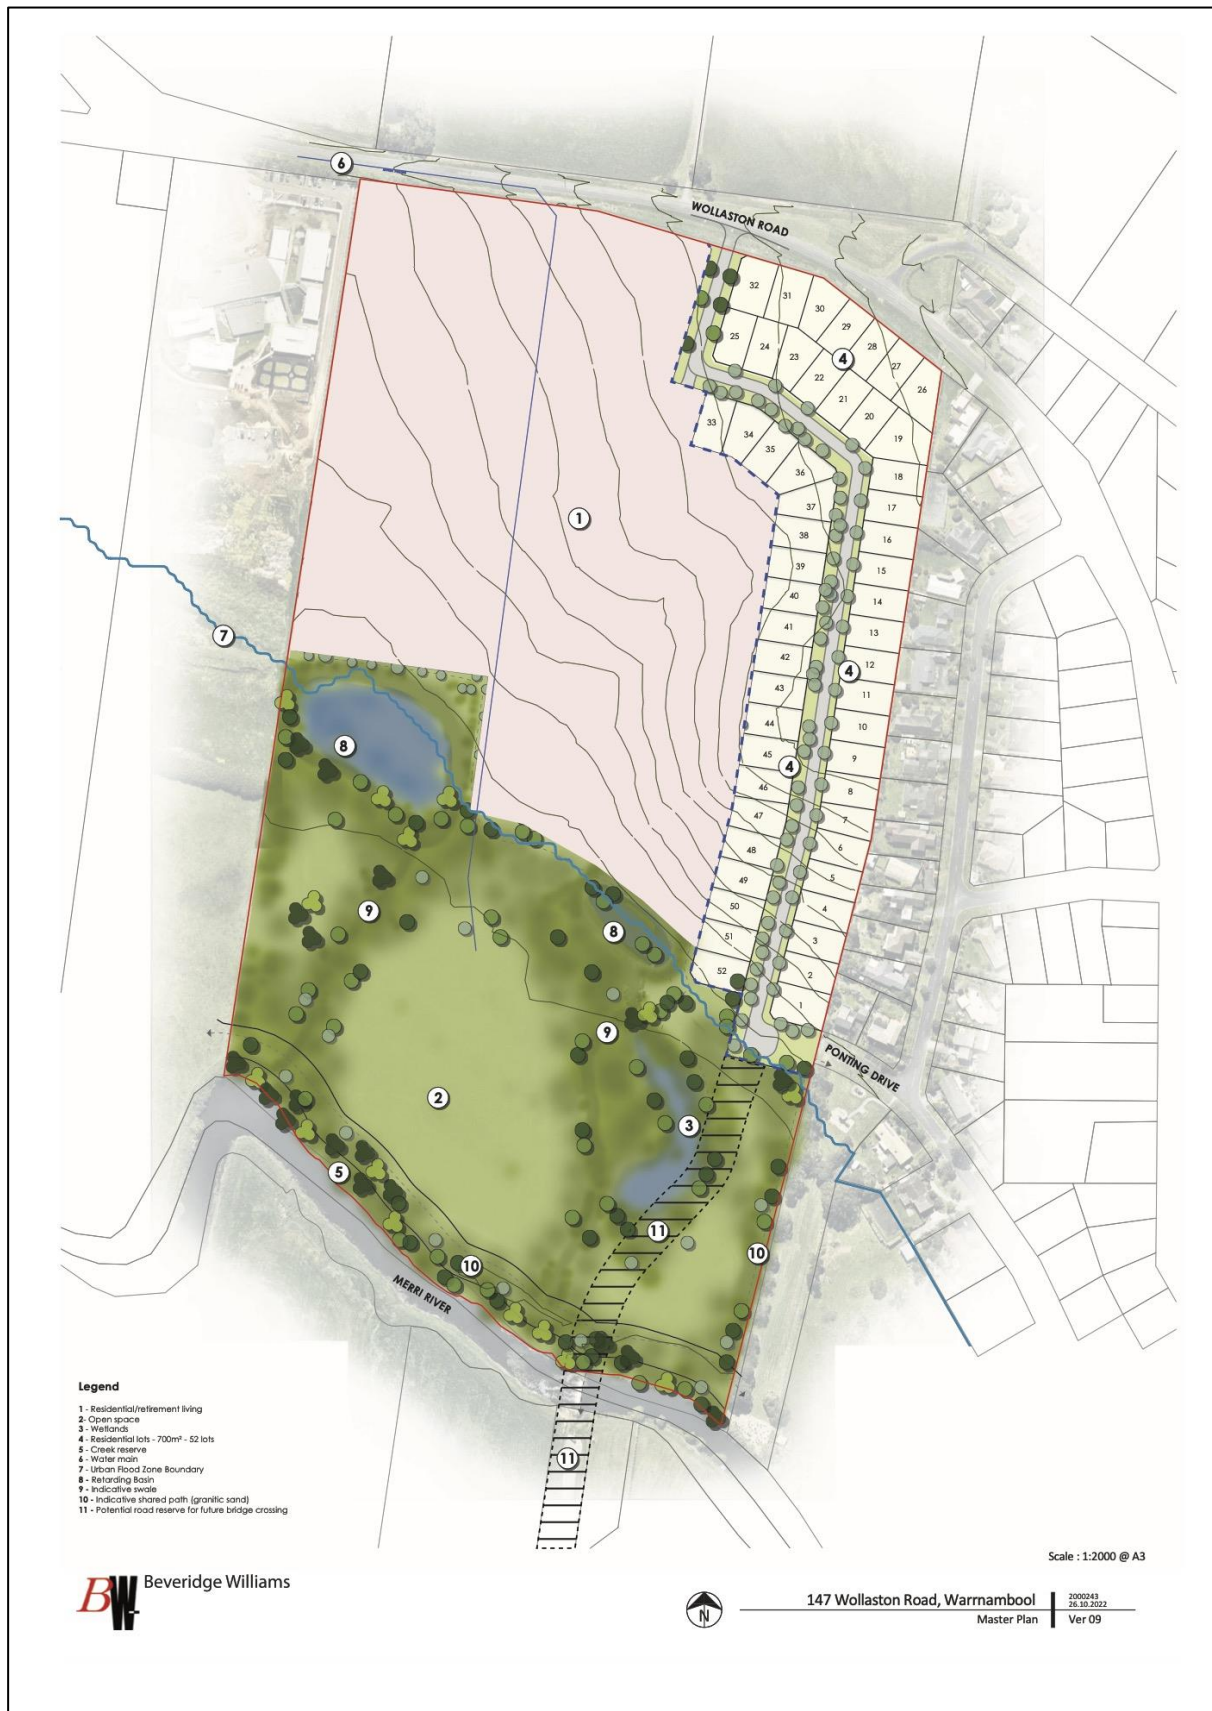
Figure 2 – 147 Wollaston Road master plan (Beveridge Williams, 2022).

The development proposal is for the staged multi-lot subdivision of the eastern part of the site with subsequent residential development, and the development of a retirement village in the western part. The site is in the currently undeveloped pastoral area to the north Warrnambool, to the south of Wollaston Road and north of Merri River. The southern part of the site is affected by the Urban Floodway Zone (and Schedule) (UFZ) and will comprise open space (see Figure 2) to be managed by Council in the future.

The proposed subdivision layout and road network will provide a single access/egress point to Wollaston Road, with the possibility of a future accessway across Merri River to the south (see Figure 2).

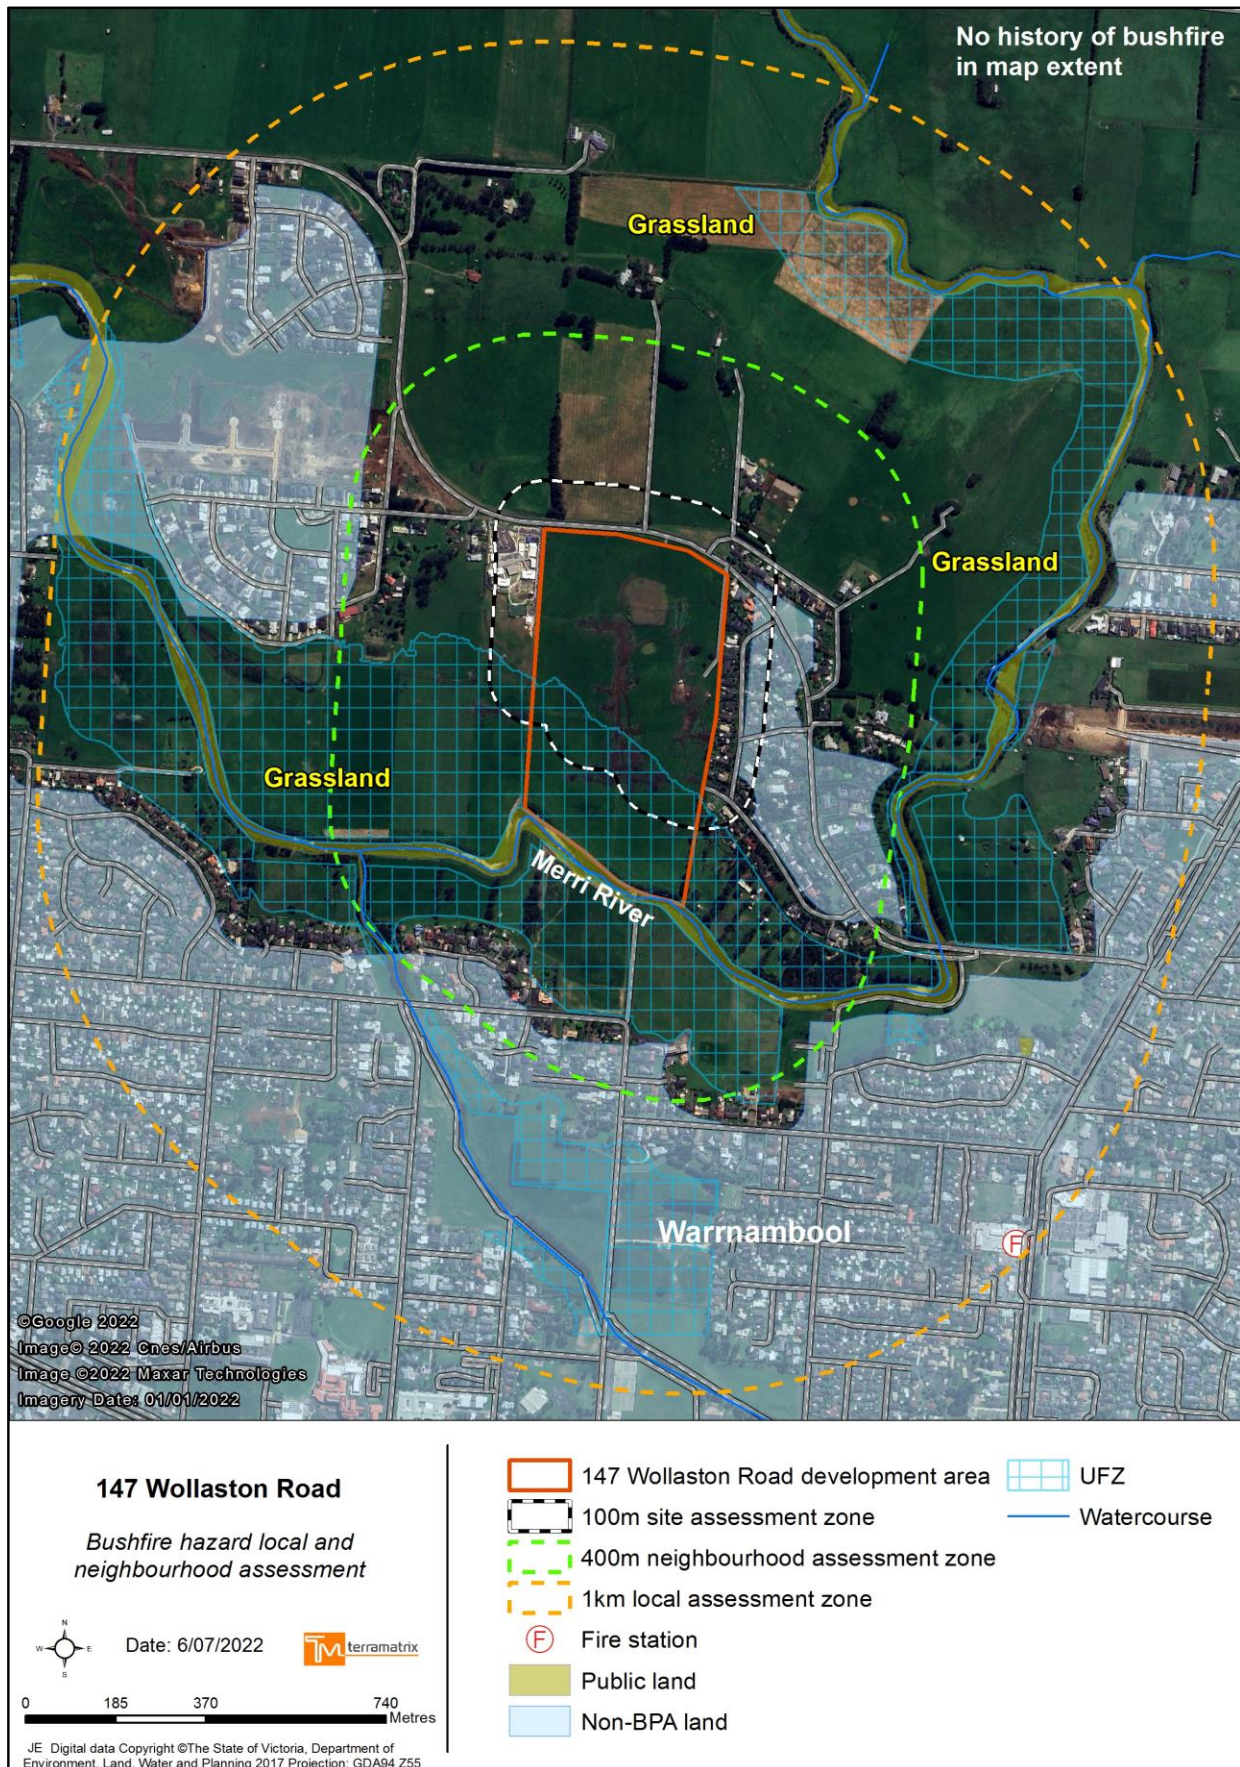
Map 2 – Local and neighbourhood hazard assessment.
