Warrnambool Breakwater – January 2018

Warrnambool City Council

Port of Warrnambool Asset Management Plan

Breakwater Assessment

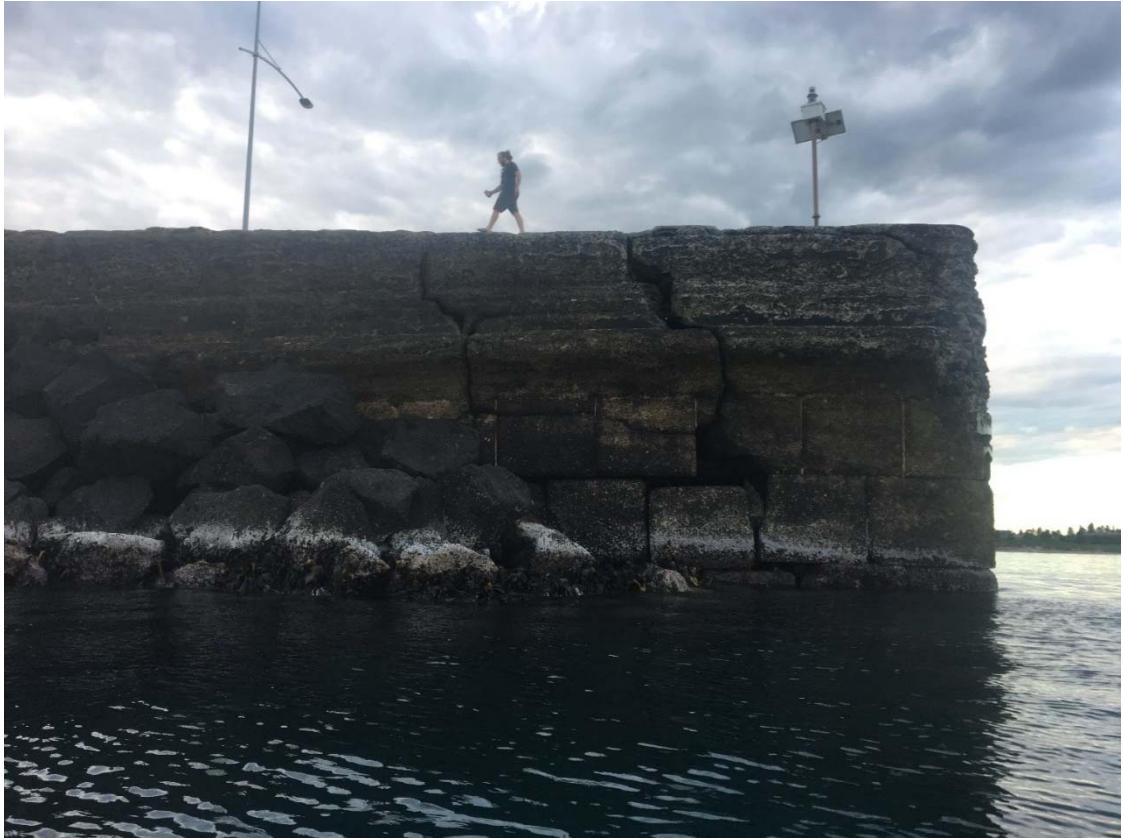
Figure 11 Armour Rocks at Breakwater Head

The estimated rock quantity required to armour length of approximately 400 m from existing armour at bollard 6 to the wall end at the aquarium along the breakwater is 80,000-90,000 tonnes. Assuming a typical section of the armour as is presented in Figure 10. The rock units are assumed to be in the range of 3.0-6.0 tonnes with nominal dimension of 1.0-1.5 m and density of 2.6 t/m^3 as per existing rock armour shown in Figure 11.

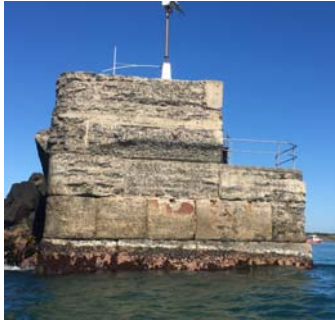
<p data-bbox="1054 2011 1407 2038">Photo 38: Eastern End of Breakwater</p>

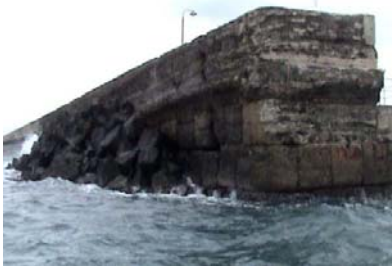
The assessment does not indicate noticeable settlement or rotation of the main breakwater since the Connell Wagner inspection in 1998. However, some evidence of increased crack widths on the main vertical cracking in the breakwater was observed above the rock protection (Refer to photos 39 & 40 in Appendix A).

<p>Photo 39: Eastern End of Breakwater, seaward face</p>

Recommendation 2 - Continue monitoring survey to identify any ongoing settlement and rotation in the main breakwater wall.

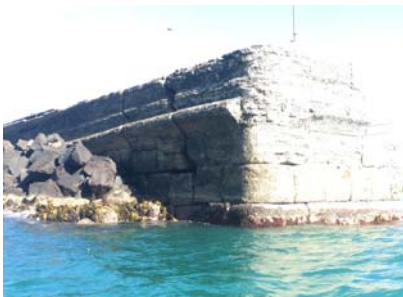
<p>Photo 40: Eastern End of Breakwater, seaward face</p>
(No Image)

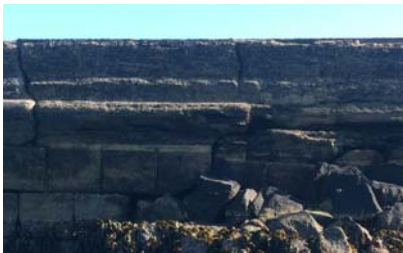
<p>Photo 42: Seaward (southern) face of breakwater at western end of rock armouring</p>

Recommendation 1 - Installation of rock armouring along the sea side of the main breakwater (from the existing armouring at bollard 5, to the rock reef at bollard 19).
