# THE HEIGHTS, South Dennington

## **DEVELOPMENT PLAN**

Planning Report

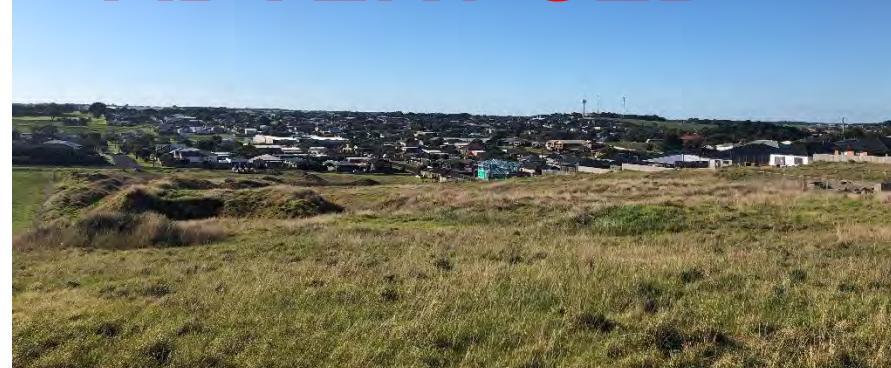
Figure 5 - Photo from Subject Site 'high-point' north towards Baynes Street

The soil profile (Painter, November 2021) is generally a silty loam with a gradual transition to sandier loam as elevation increases. There are some larger pockets of sand underlying calcarentie accumulations within the dune landform, not found within the swampy floodplain landform which contains fill deposition and considerable ground disturbance.

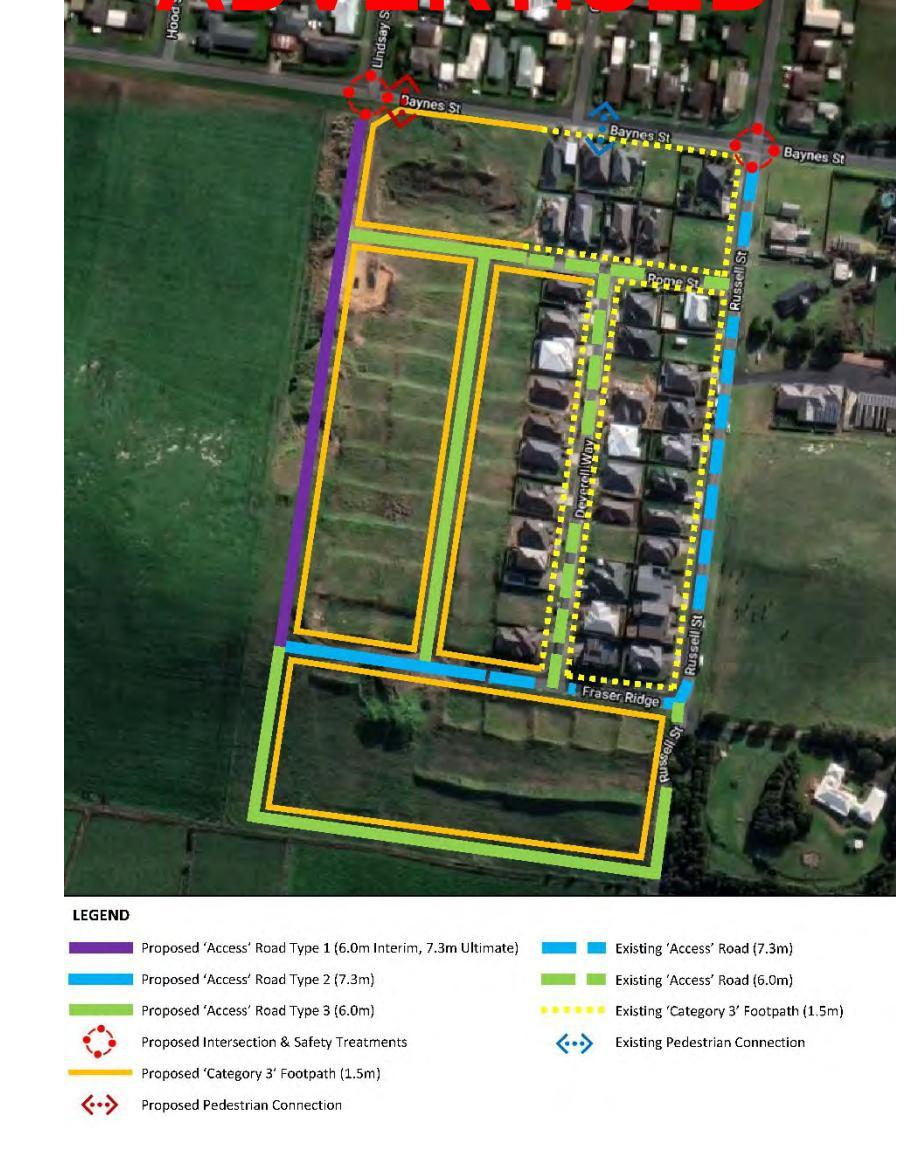
Figure 13 - Development Plan Proposed Road, Pedestrian and Cycling Networks

Further information can be found in the Traffic Assessment Report (Appendix E) relating to road cross sections, intersection treatments, and traffic calming.

While the Traffic Assessment Report (Appendix E) acknowledged a roundabout is ideally constructed at the Baynes Street / Lindsay Street intersection the delivery of the roundabout without adjoining land being developed presents some challenges. The report recommends that a financial contribution (such as a Development Contribution) towards the roundabout is provided. This contribution, plus the allocation of land on the Subject Site allows for the roundabout to be constructed later when the traffic treatments are warranted and can be integrated with the development to the west.

The proposed residential development within the entire Development Plan area (including previously constructed stages) is estimated to generate 1,100 vehicles per day, with estimated additional morning and afternoon peak traffic of 94 vehicles per hour and assessed that the development would not adversely affect traffic conditions, the safety or operation of surrounding road and footpath networks as outlined in the Traffic Assessment Report (Appendix E).

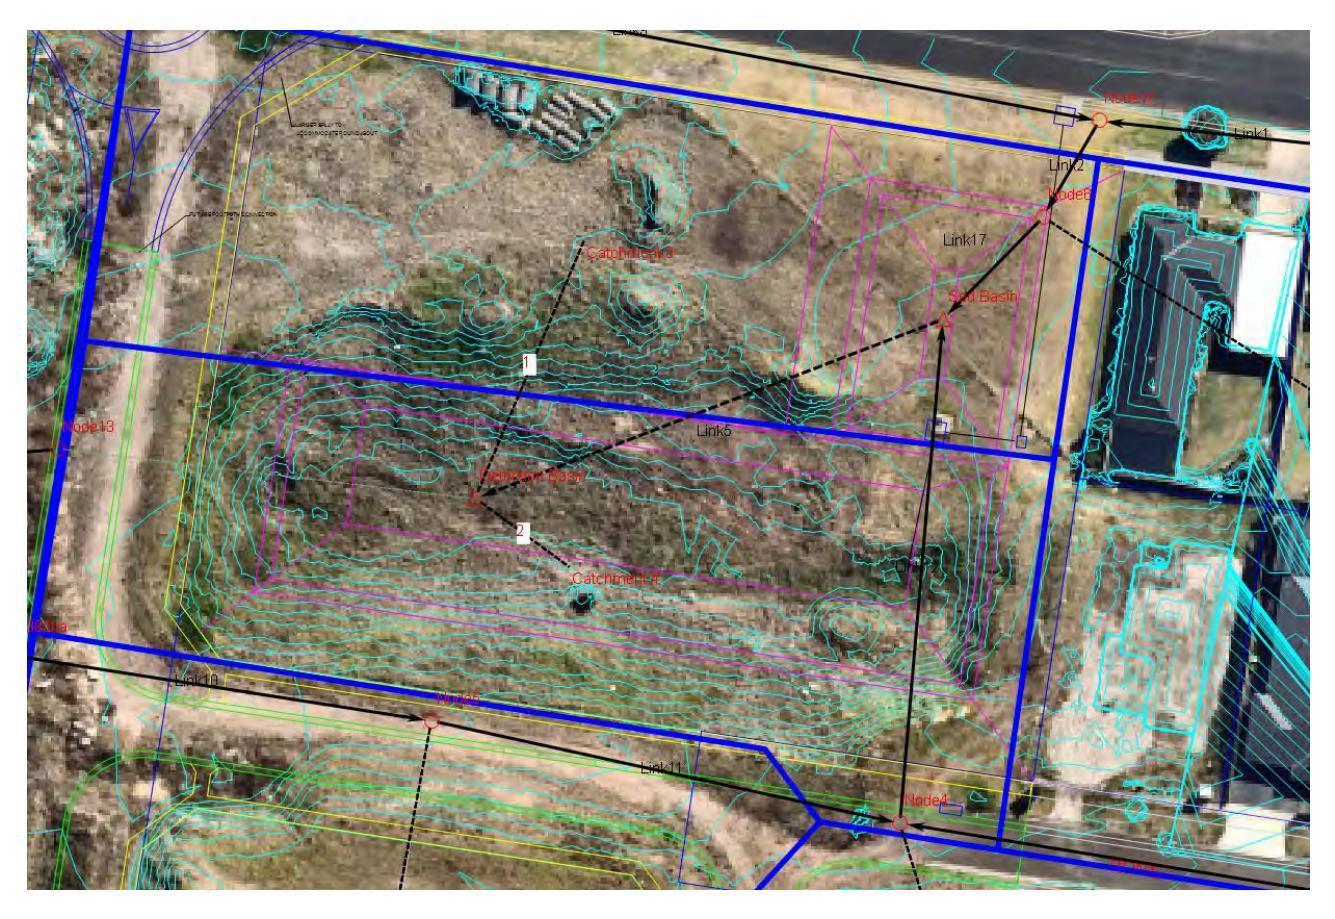
Figure 10: Hydraulic Model for Northern Detention Basin

No outflow link was provided in the above model which represents the current basin scenario and all outflow is via constant infiltration.

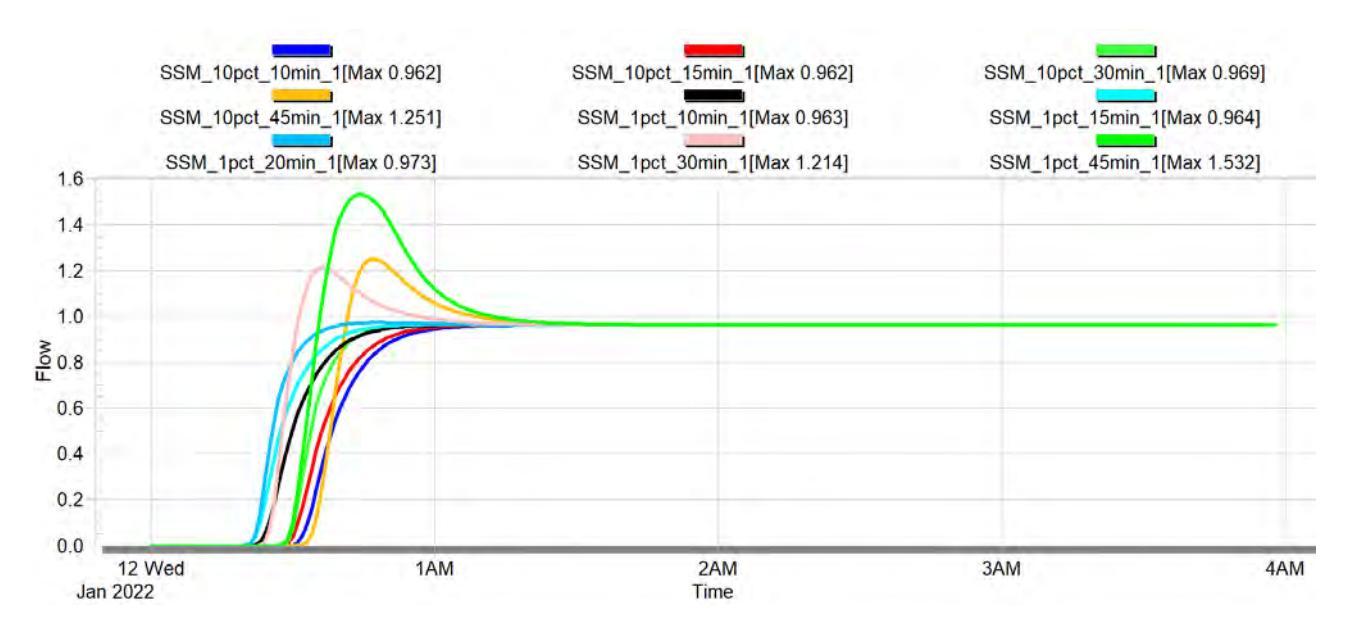
Figure 16: Outlet flows - 1200Is option

The basin fills from the incoming storm events and constant inflow which is 10 times higher than the infiltration rate of the basin.

The resulting flow of 1.0m3/s are then conveyed downstream via a proposed 900mm outlet pipe to Merri River.

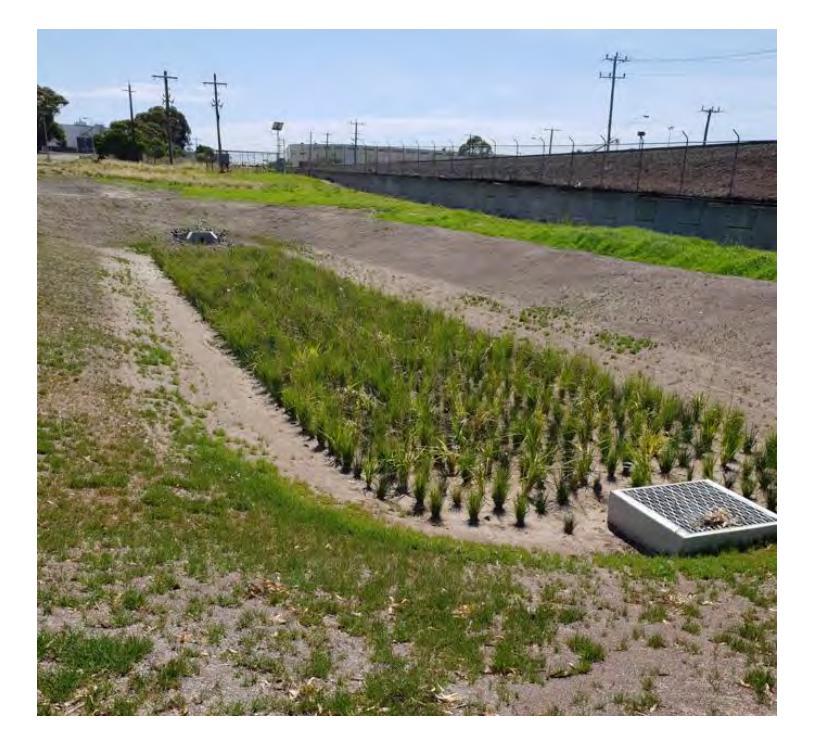
Figure 18: Bio-basin at base of retardation basin

Water quality objectives will be met from the site via a sediment and bioretention basin in the base of the retarding basin on site similar to the arrangement below:

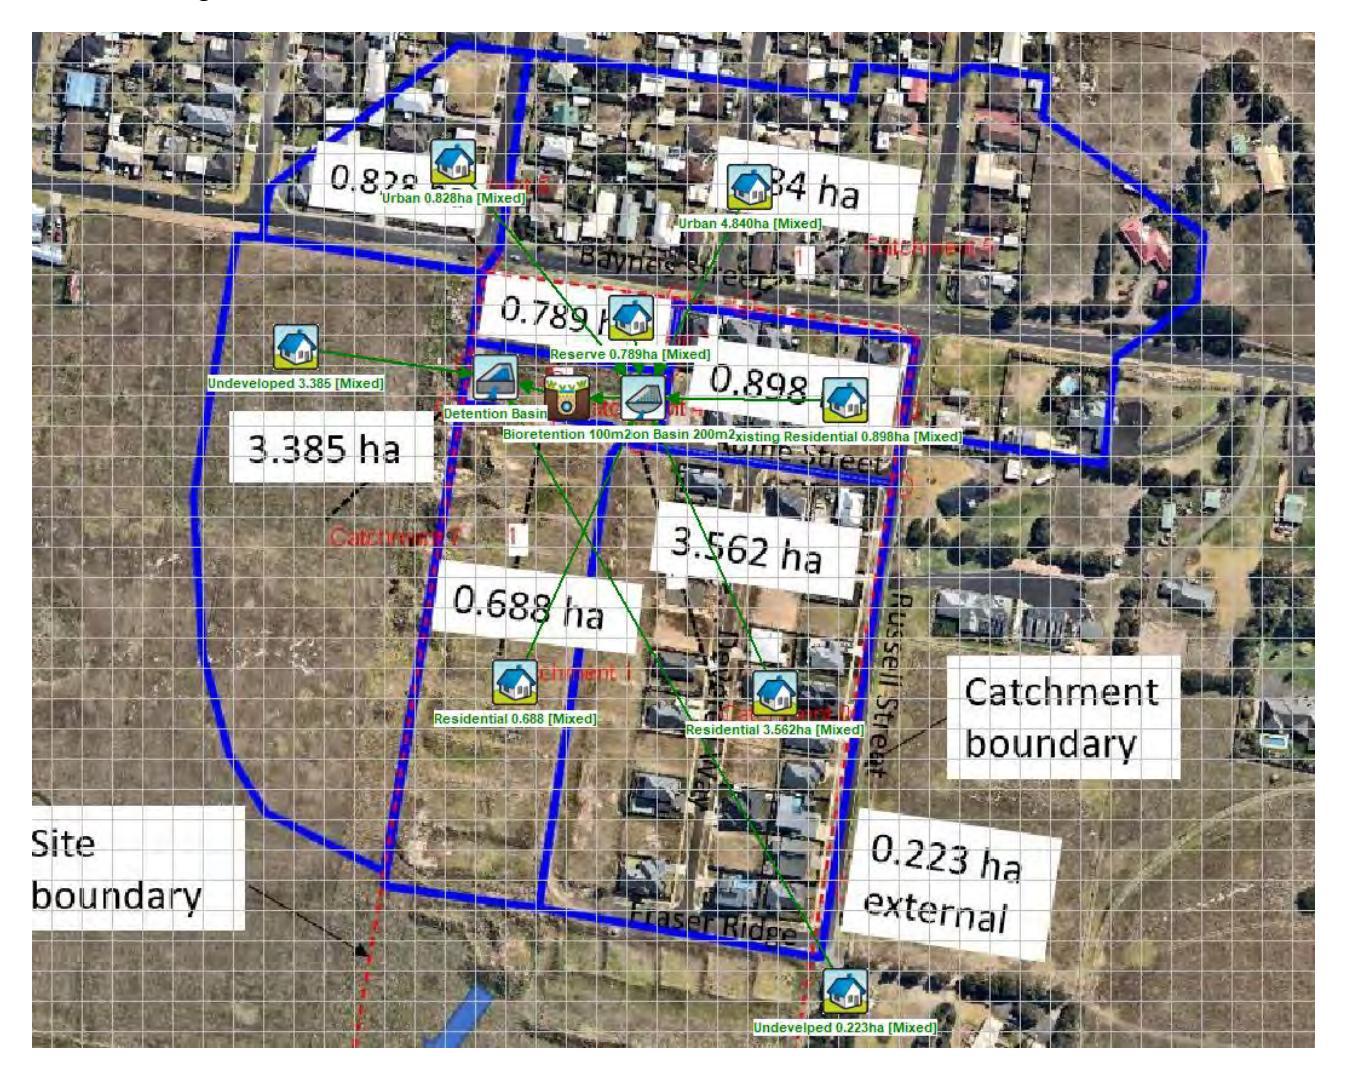
Figure 21: MUSIC Model Layout

The bioretention basin is assumed to engage as the sediment basin overflows to treat the finer colloidal fraction and soluble pollutants.

The biobasin infiltrates directly to the underlying sands and overflows into the wider detention basin.

The result indicates that the basin is effectively removing all pollutant and flow due to the infiltration into the underlying sandy soils.

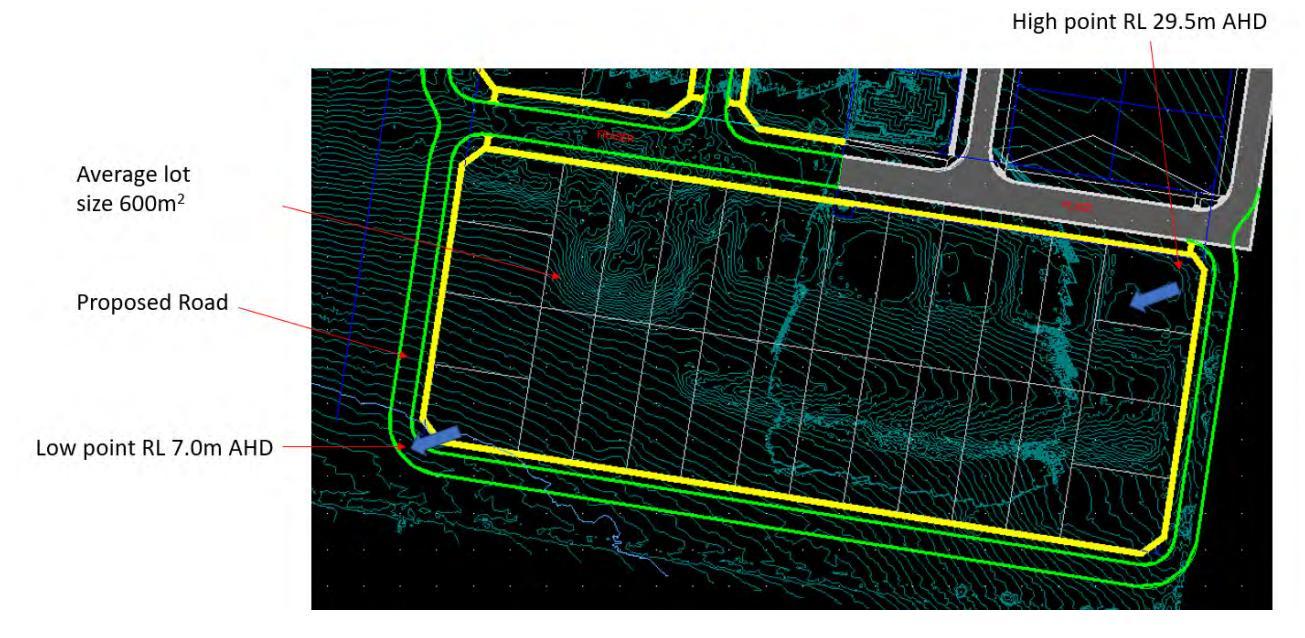
Figure 22: WSUD Layout

For lots south of Fraser Place, the land slopes at a 10.7 degree slope to the south west corner.

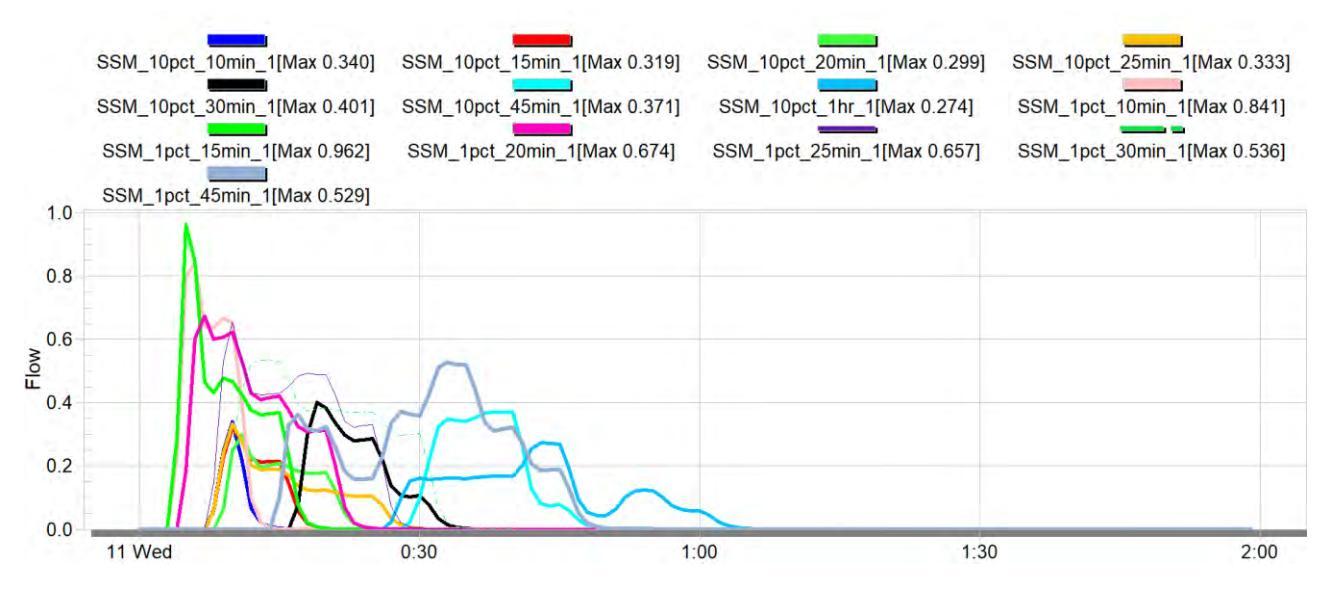
Figure 24: Fraser Place South - Post-Development Flows

100yr AEP: 0.962m3/s - 15min critical storm

As the above flows are higher than pre-development, it is required that detention be provided to reduce the post development flows to match the previously calculated existing conditions flows.

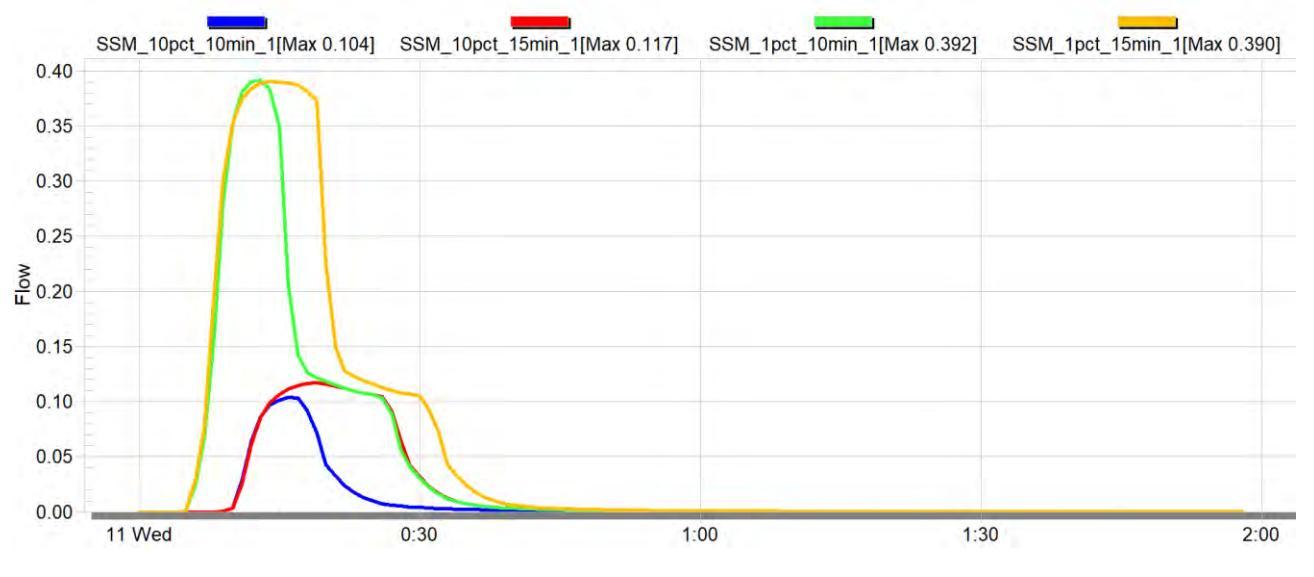
Figure 25: Fraser Place South – Retarded Post Development Flows

Through iteration, it was found that a combination of a 140m3 storage controlled by two outlets can closely match pre-development flows for the 10 year and 100 year events.

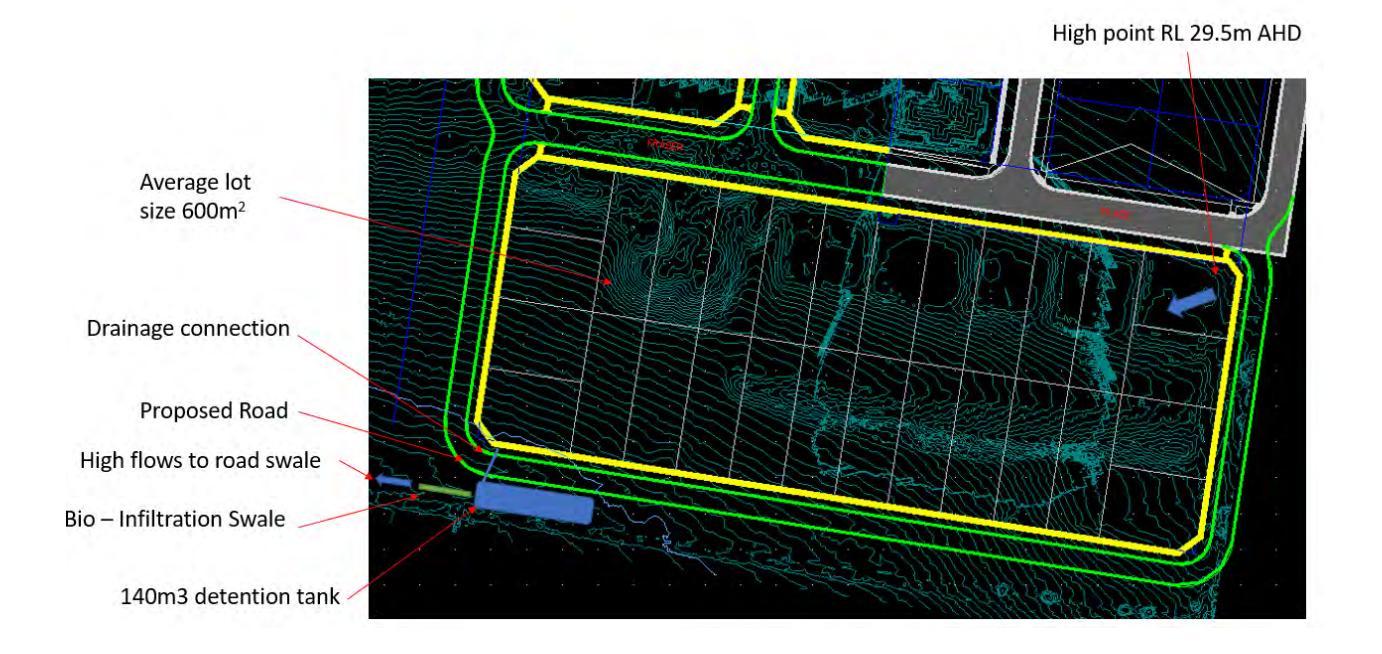
#### Figure 27: Fraser Place South – WSUD Plan View

Outfall from the tank will flow into a 20m long bioswale that infiltrates into the underlying sands and higher flows will continue to follow the natural fall of the land along the wider road reserve towards the Merri River.

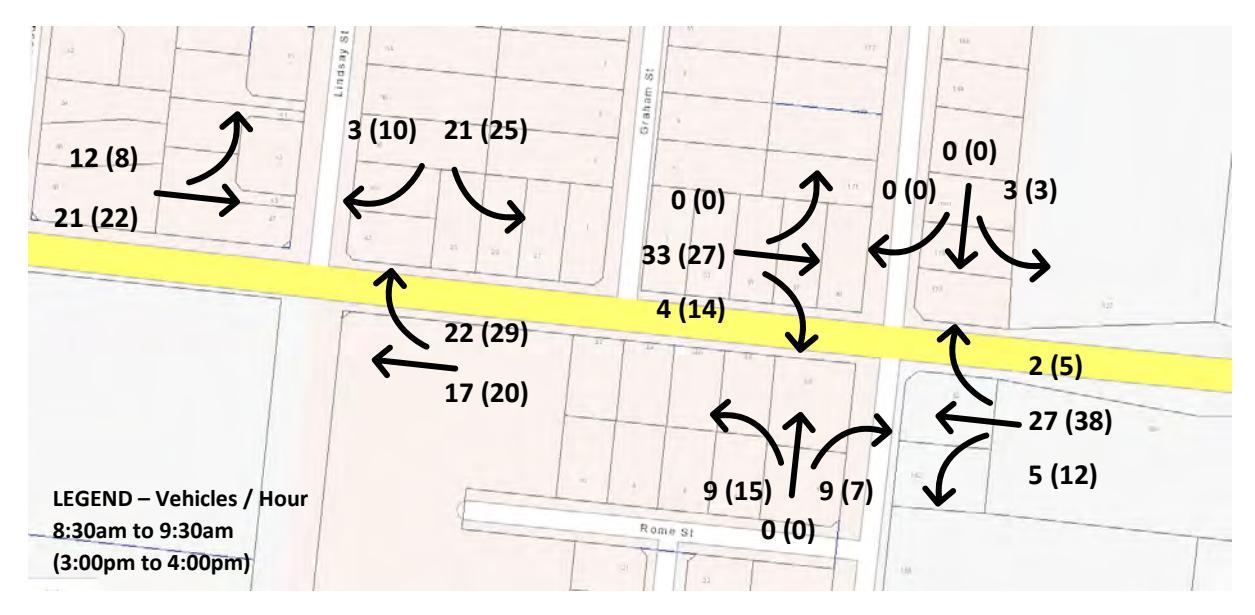
Figure 17 - Existing Traffic Conditions during AM(PM) Surveys

The Consultant has undertaken traffic count surveys to validate the existing traffic conditions of the surrounding road network specifically along Baynes Street at the Lindsay Street and Russell Street intersections. Turning movement count data (Appendix B2) was captured on Friday 30<sup>th</sup> July 2021 between 8:30am – 9:30am and 3:00pm – 4:00pm which cannot be confirmed as peak volumes but presents a mix of school pick-up / drop-off and commuters. Note that there were no travel restrictions in place related to COVID at the time of the survey.

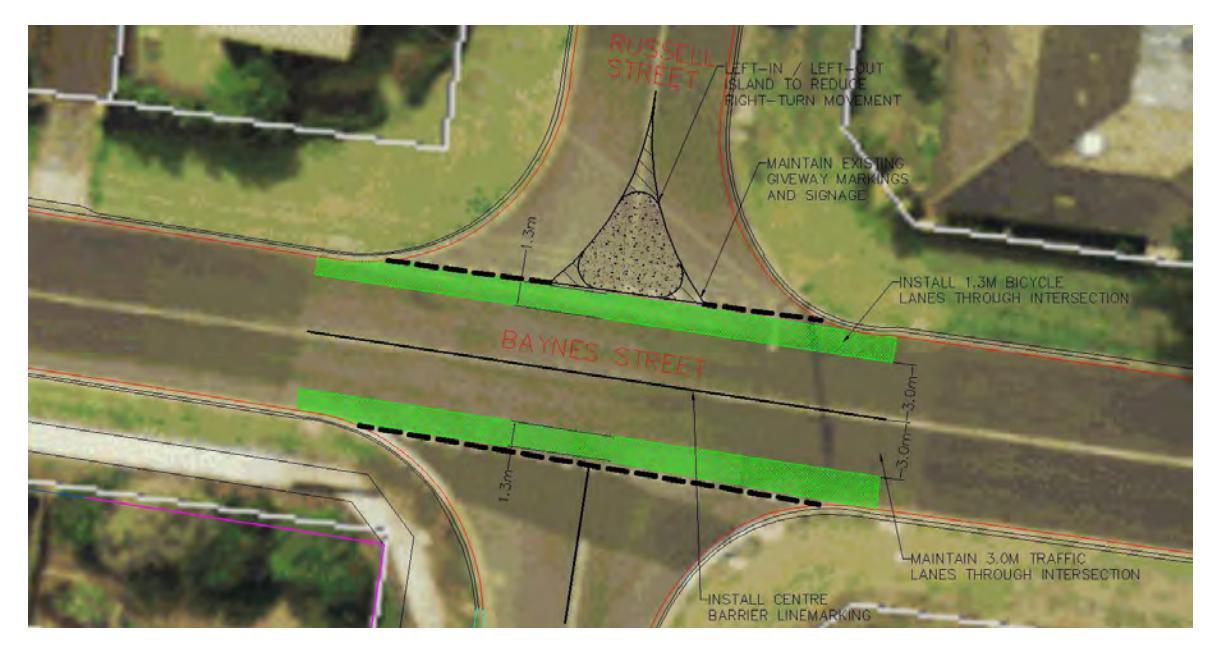
Figure 20 - Concept Intersection Treatment, Baynes Street / Russell Street

The main safety risk relates to the right-turns in and out of Russell Street, calculated to be 14 vph. Given the low traffic volumes of right-turning vehicles expected, with the available queuing space and the 50km/h posted speed limit the treatment recommended uses visual cues, lane narrowing and left-in / left-out treatments for local access and provisions for an on-road bicycle lane to encourage slower vehicle approach speeds that improve the safety of movement.

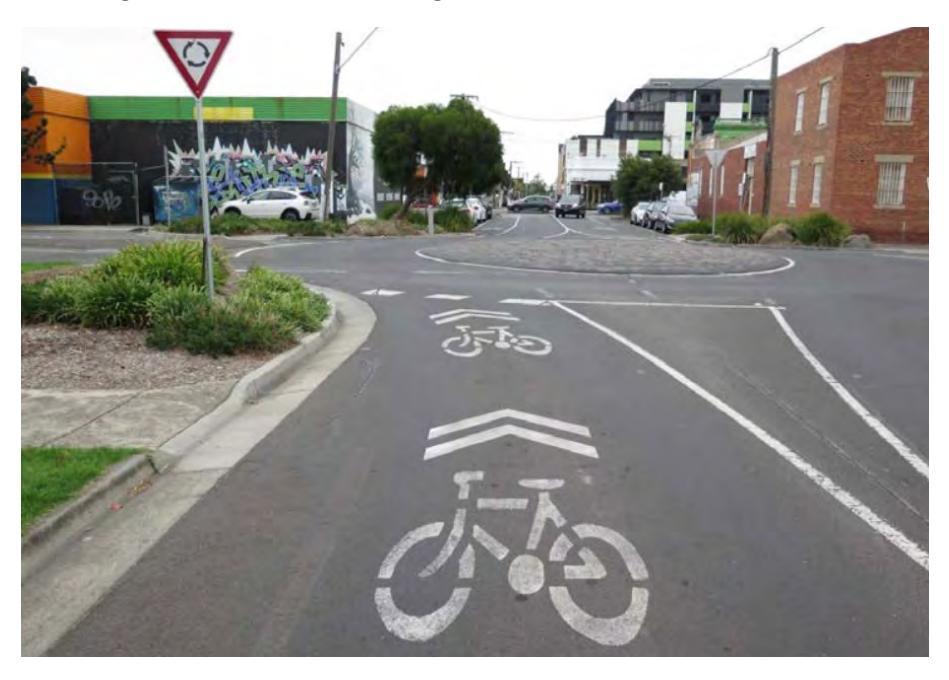
Figure 23 - Example of sharrow pavement markings at a roundabout (VicRoads, December 2016)

Sharrows are pavement markings consisting of a bicycle symbol and two chevron markings and may be used on the approach to an intersection where a bicycle lane or similar facility terminates prior to the intersection, and cyclists are required to merge into the main traffic lane. The intention of sharrows is to position cyclists into the centre of the traffic lane at individual intersections and encourage them to mix with through traffic.

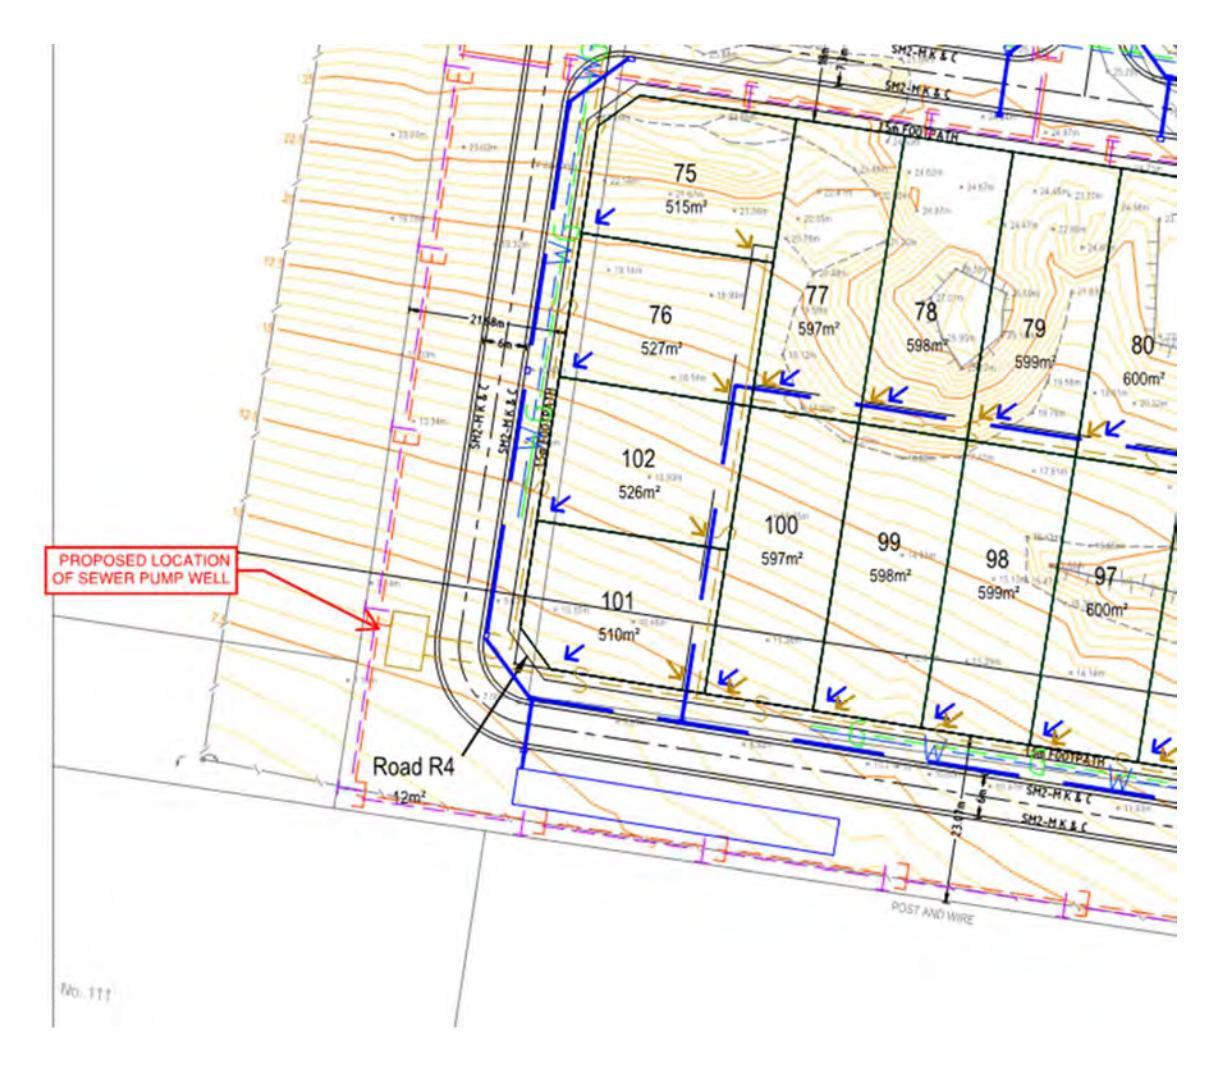
Figure 2: Proposed location of sewer pump well

The proposed pump station is a temporary system and hence will be likely be removed in the future, because of this it is not necessary to locate the system in a dedicated permanent services reserve. Within the existing road reserve there is more than ample room to house the system and when the land to the west is developed the pump station may be decommissioned or relocated to the next low point with no residual land left behind. Figure 2 shows the proposed location of the pump well in the road reserve in the South-West corner of the development, this is recommended as the most viable option.

To the south of Fraser Ridge there is no existing Sewer infrastructure and due to the site's topography it is not feasible to connect this via gravity into the existing infrastructure on the North of the ridge. As a result we recommend a temporary sewer pump station to manage the wastewater from the 28 lots that lie to the south of Fraser Ridge. Figure 1 depicts the proposed cross section of the pump well, with a minimum operating volume of 900 Litres based on a desirable 5 pump starts per hour and an appropriate pump rate of 2 Litres/Sec.

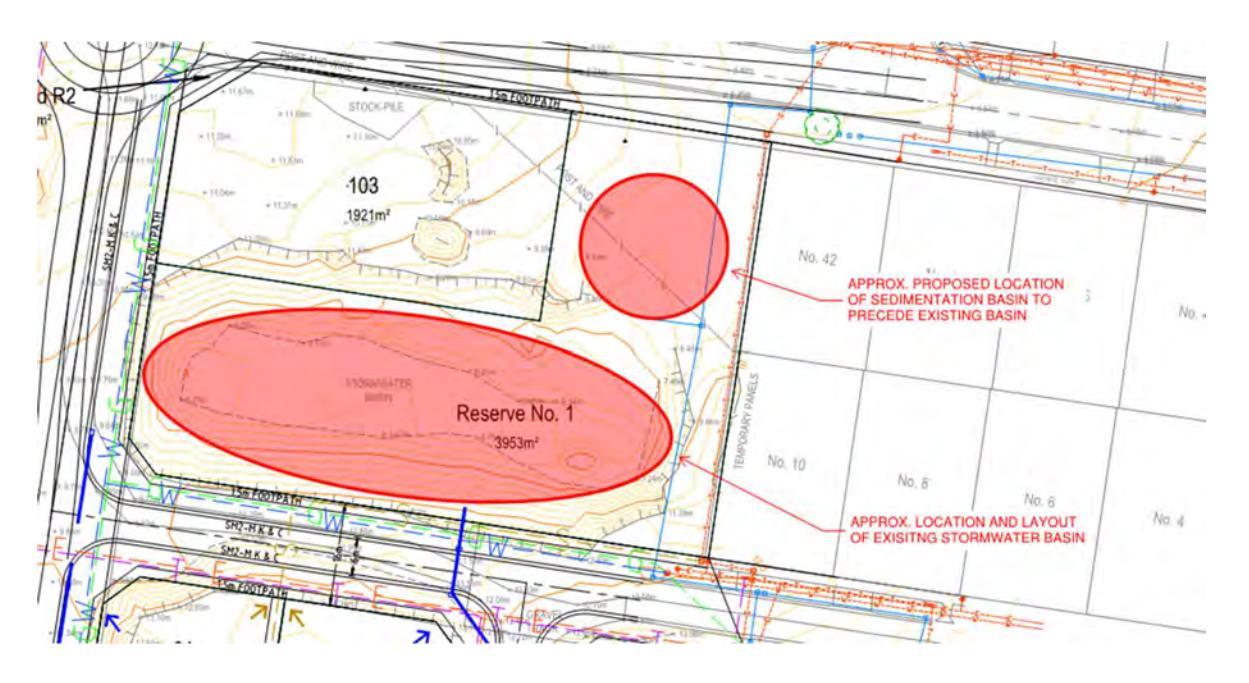
#### Figure 4: Sketch of Proposed Basins Layout

To support deferral of complete construction, it is proposed to provide similar pre-treatment capacity, to maintain the capacity of the infiltration media. This may be provided by a sedimentation basin, or alternatively by a sacrificial filter layer within the main basin.

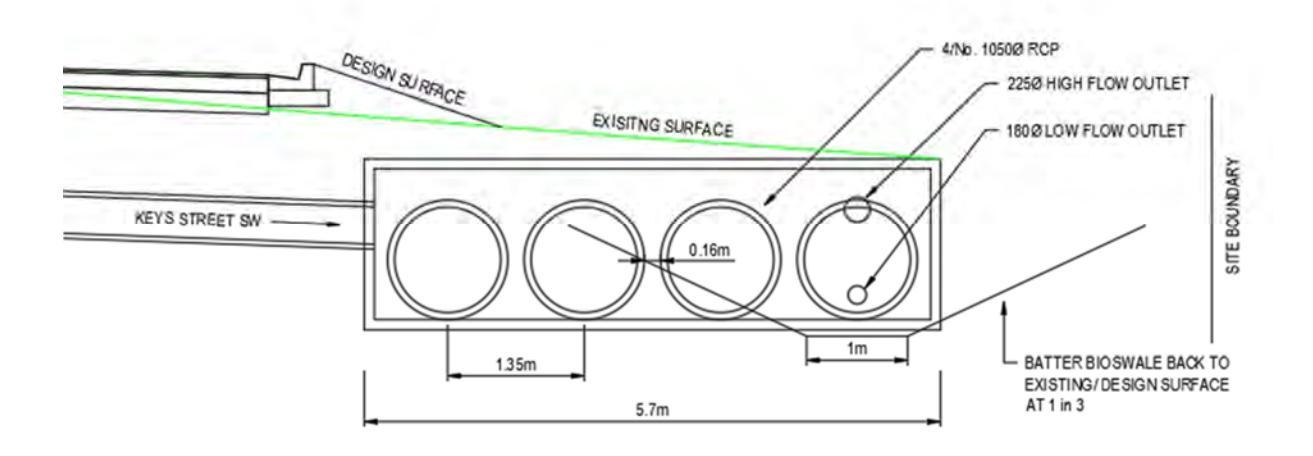
Figure 5: Detention/Infiltration system cross section

To the south of Fraser Ridge there is no existing drainage infrastructure and runoff follows the existing topography to the West towards the Merri River. As noted within Noyce Environmental Consulting report it is proposed to construct a detention system consisting of 4/No. 1050Ø R.C Pipes and a 20m long bio-swale for treatment and infiltration. An approximate cross section of the proposed system is detailed in Figure 5. A Gross Pollutant Trap will be located immediately prior to the detention system.
